ASSESSMENT DATA DEFINITIONS

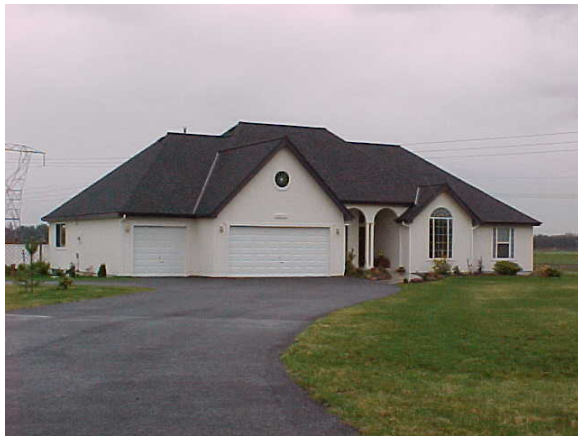
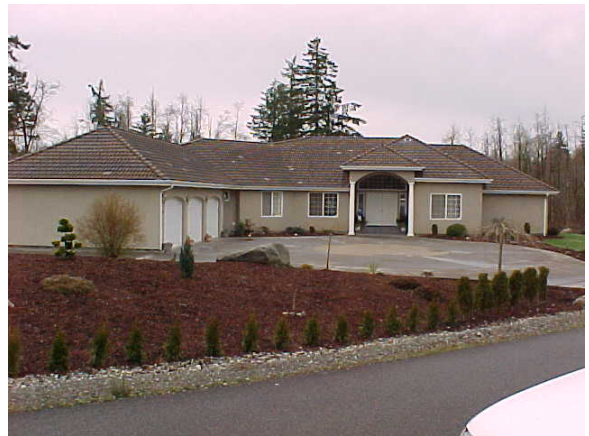
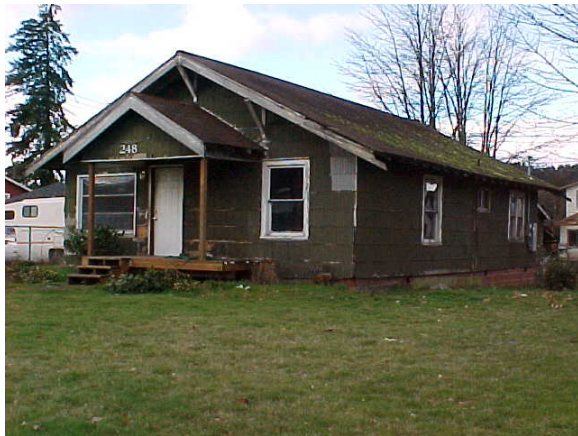
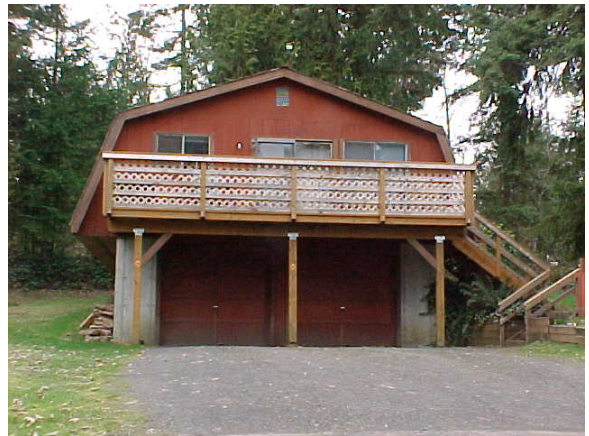
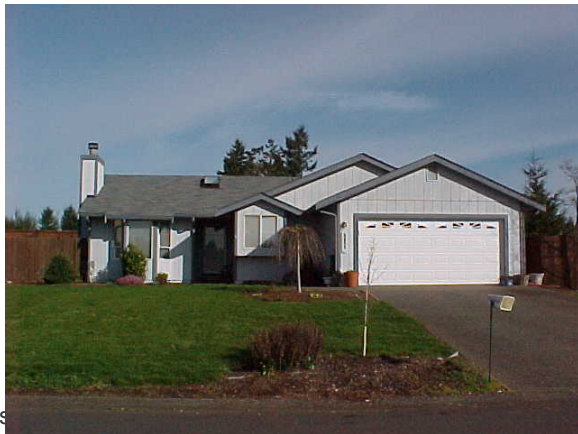
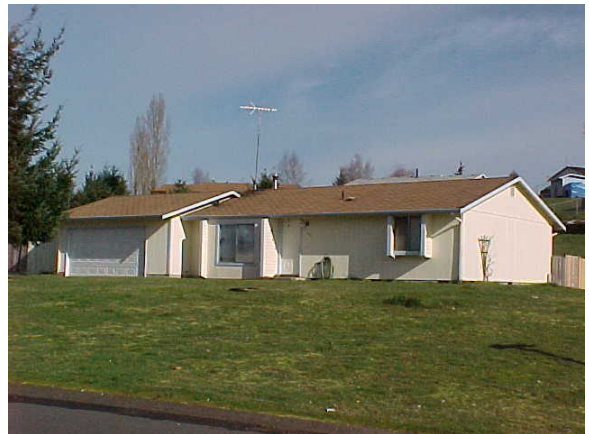
Rambler

Possible attic area may or may not be finished. Attic areas are measured based on the layout of the inside walls.

May have a basement that may or may not be finished

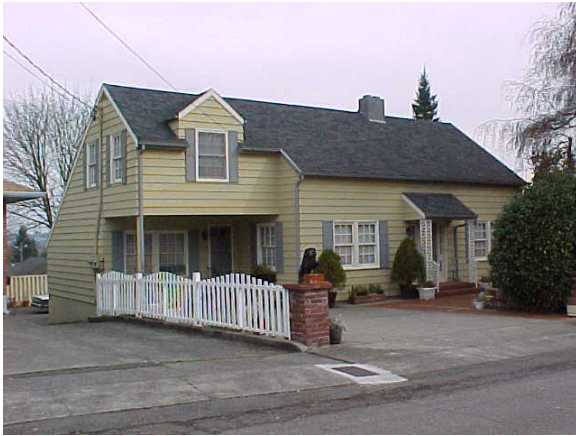
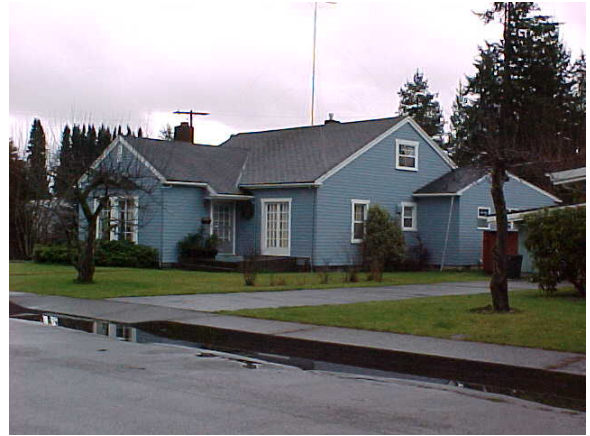
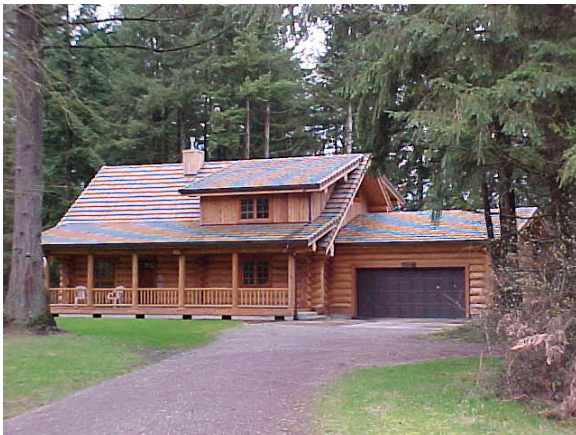
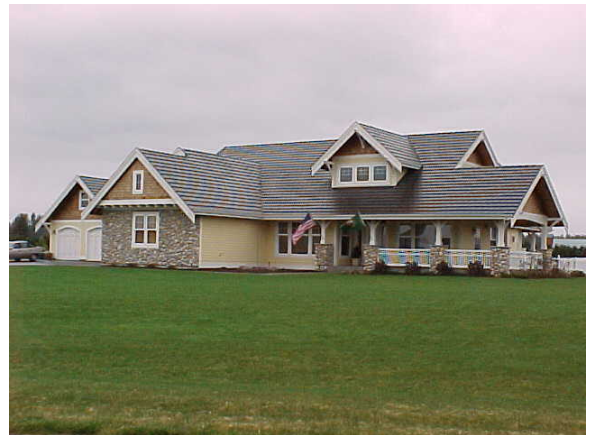
One And A Half Story

Number of stories: 1.5

Half stories are determined by presence of dormers or half height outer walls. Half story areas are measured based on the layout of the inside walls.

May have a basement that may or may not be finished

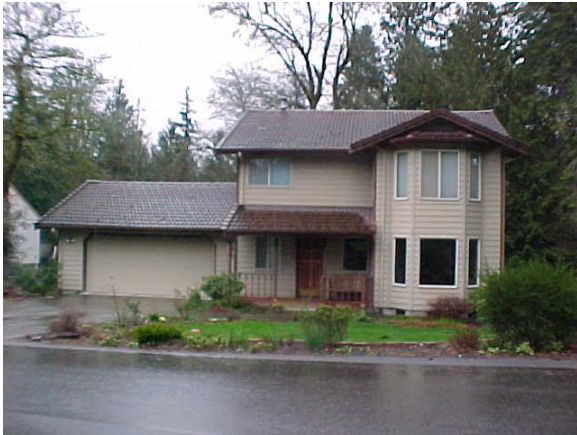
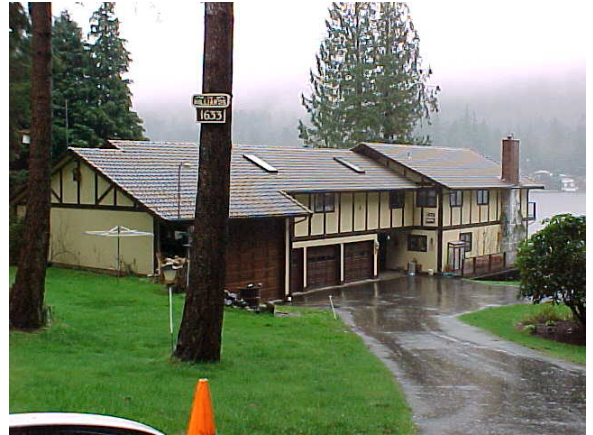
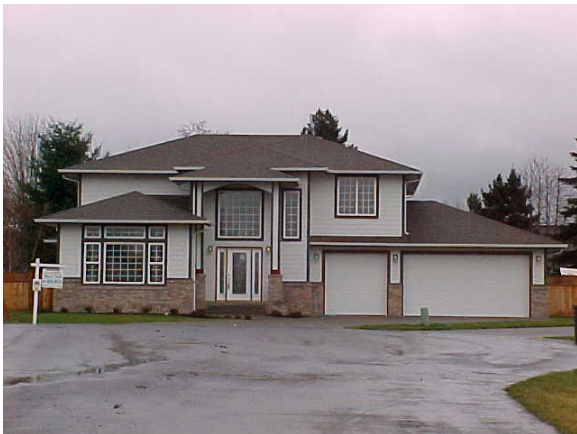
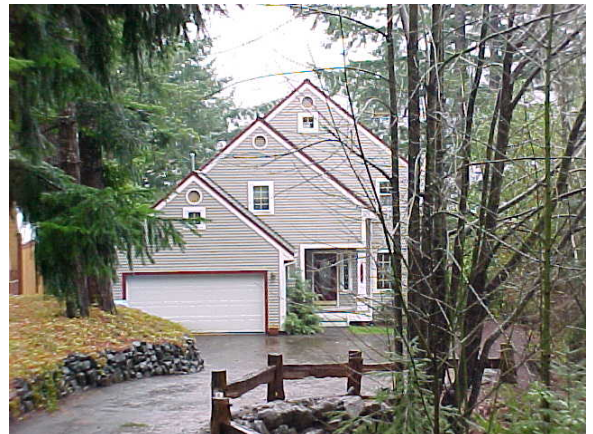
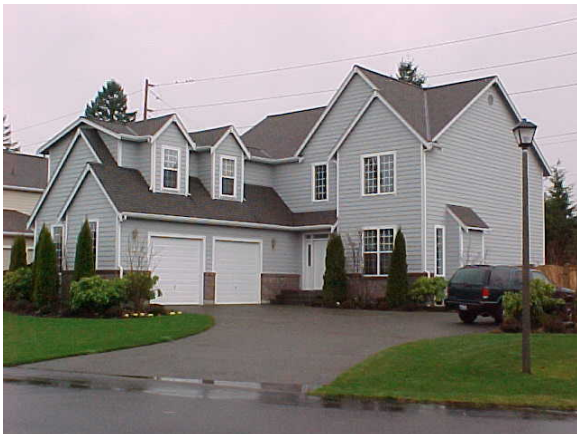
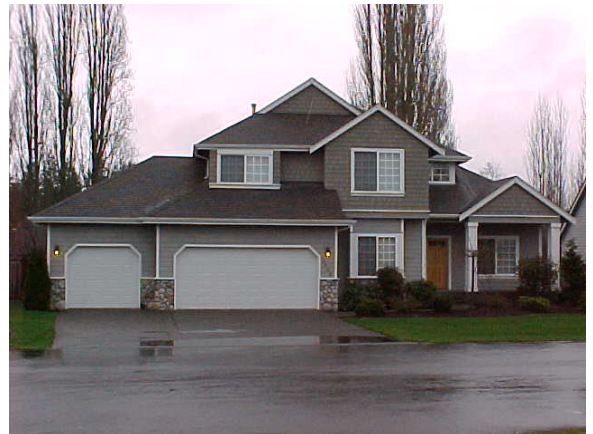
Two Story

Number of stories: 2

May have attic area that may or may not be finished. Attic areas are measured based on the layout of the inside walls.

May have a basement that may or may not be finished

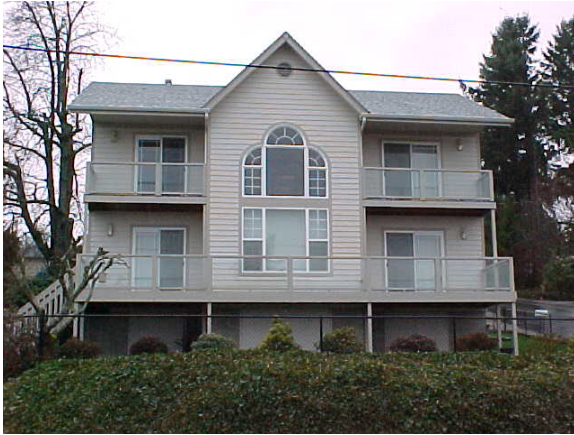
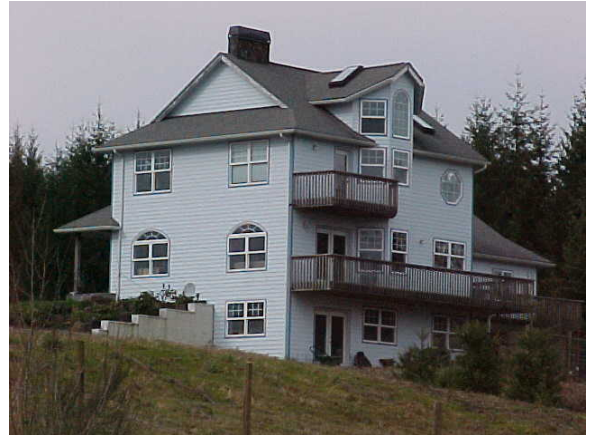
Two + Story

Number of stories: 2.5, 3, 3.5, etc.

Half stories are determined by presence of dormers or half height outer walls. Half story areas are measured based on the layout of the inside walls.

May have a basement that may or may not be finished

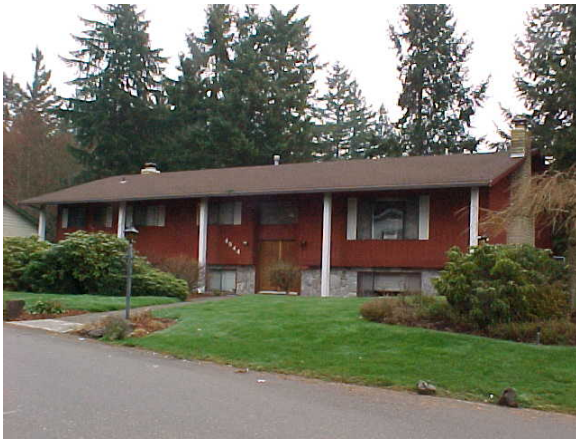
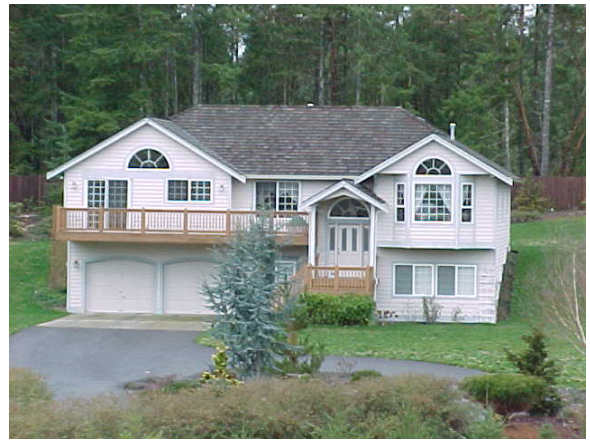
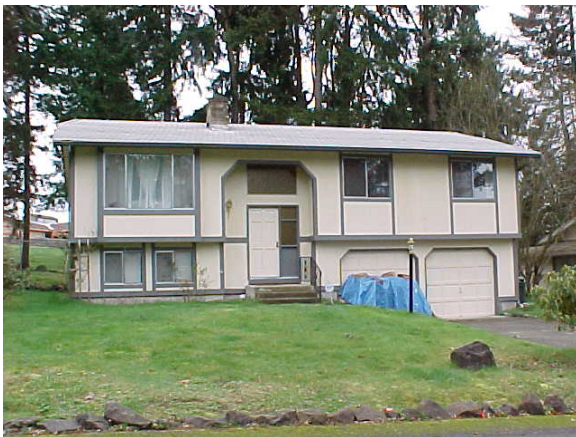
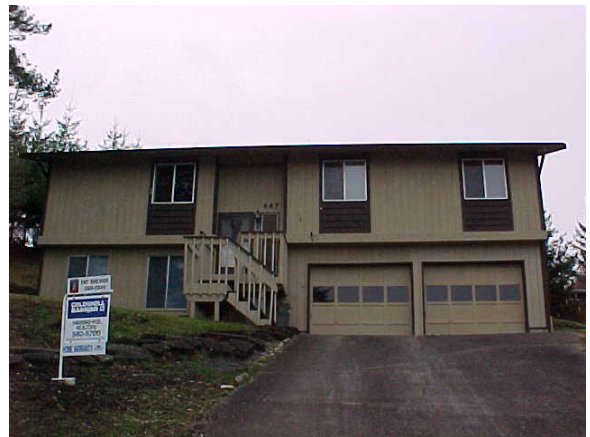
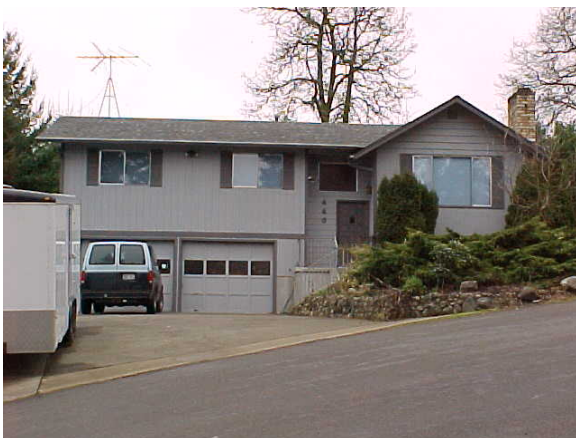
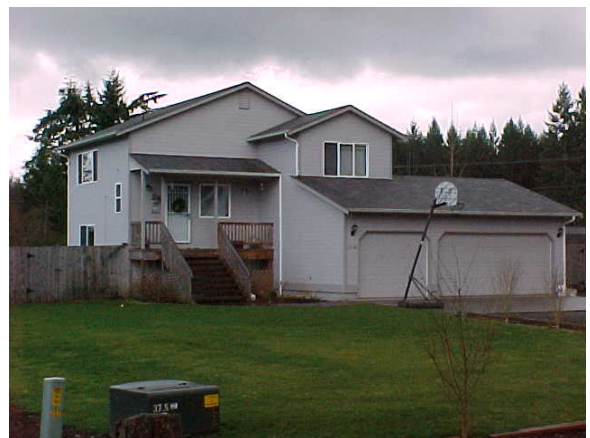
Split Entry

Number of stories: 1 with basement if lower level is partially below grade or 2 if lower level is above grade

If one-story, the lower level is entered as basement area and the second level as main floor area.

If 2-story, the lower level is entered as main floor area and the second level as upper floor area. Any basement area may or may not be finished.

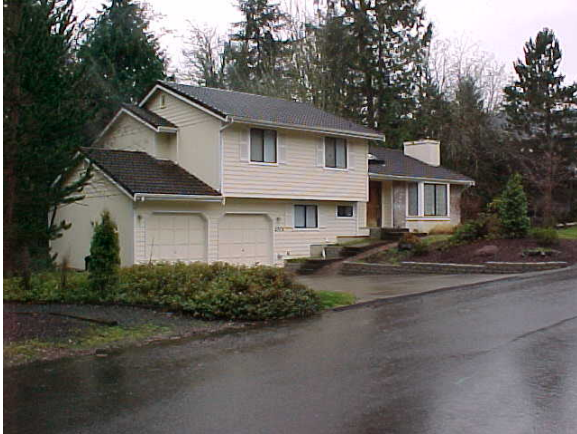
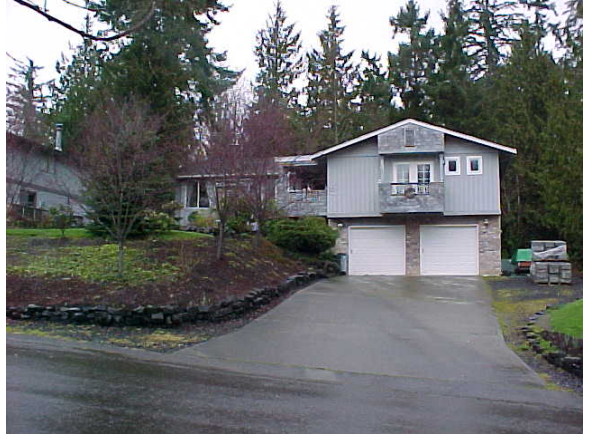
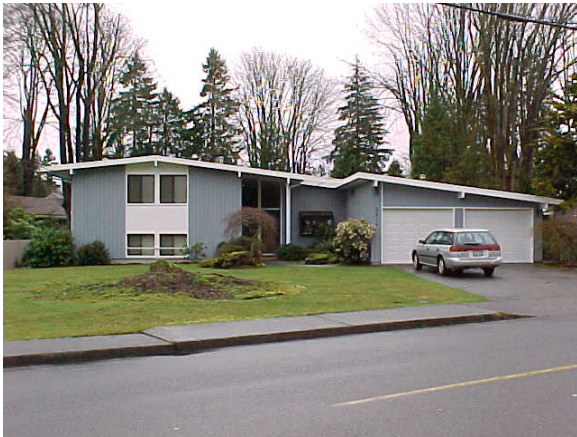
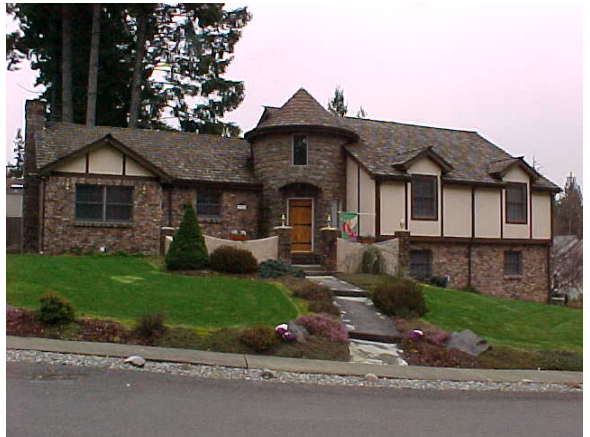
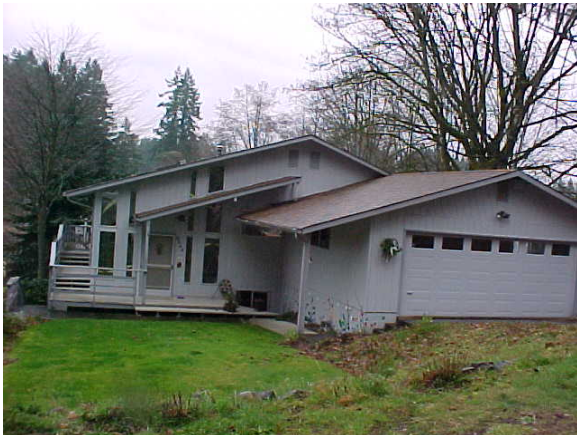
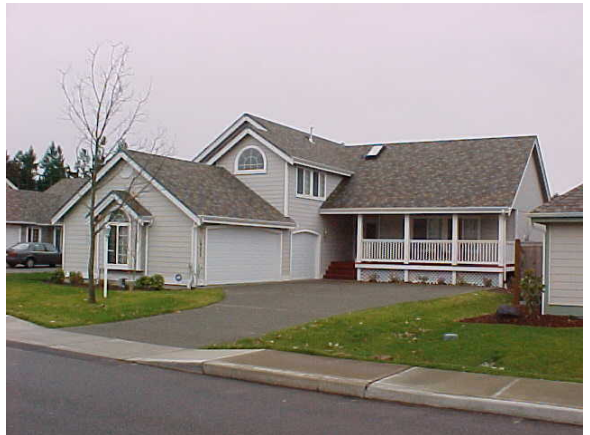
Split Level

Number of stories: 2

Garages should be entered as attached or built-in.

All three levels are typically finished and are of equal quality.

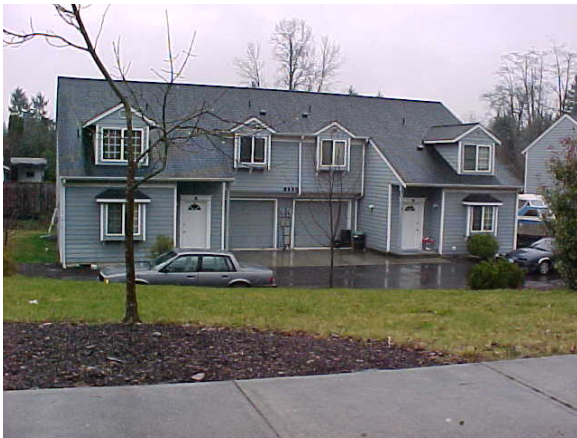
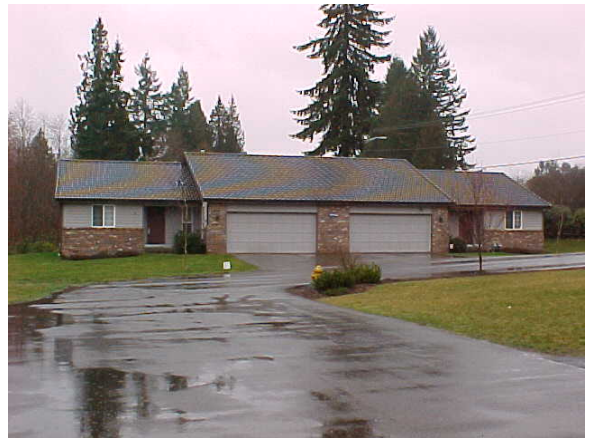
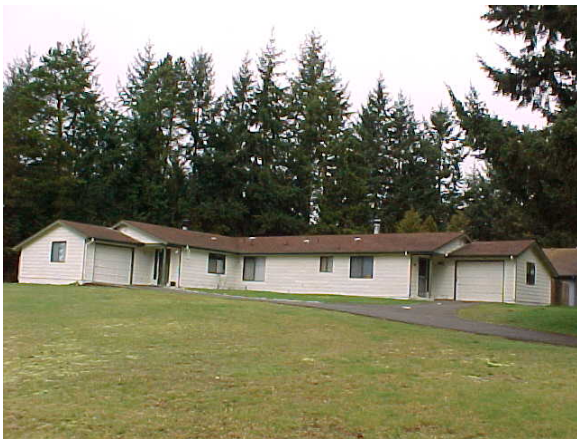
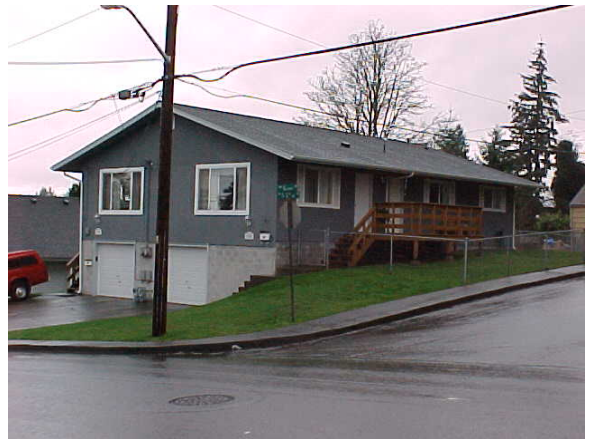
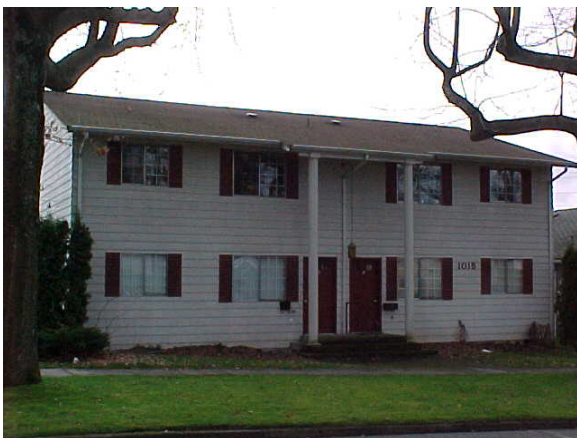
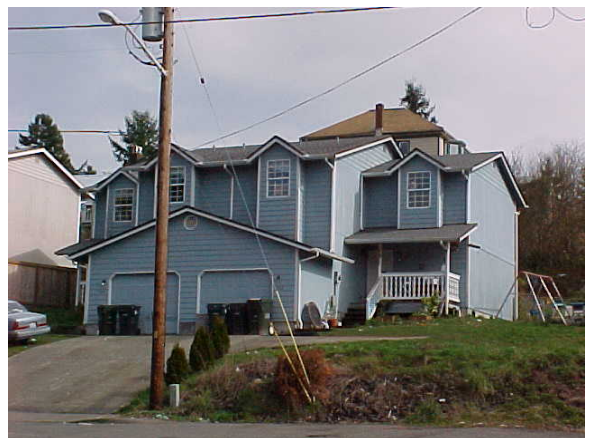
Duplexes

They can be similar in style to ramblers, one & one half stories, two stories, and split entries. Floor areas, basements, and garages should be entered based on the closest corresponding building style.

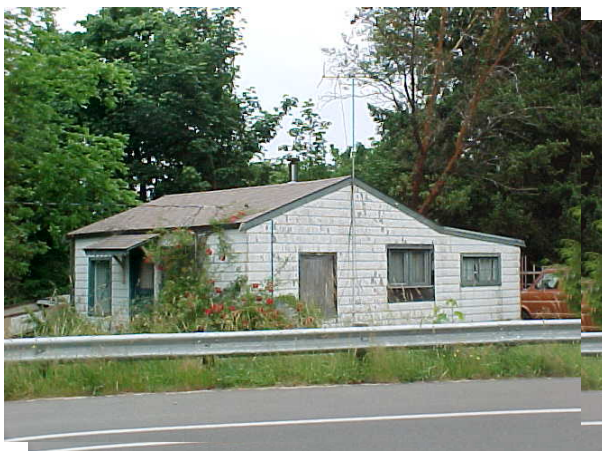
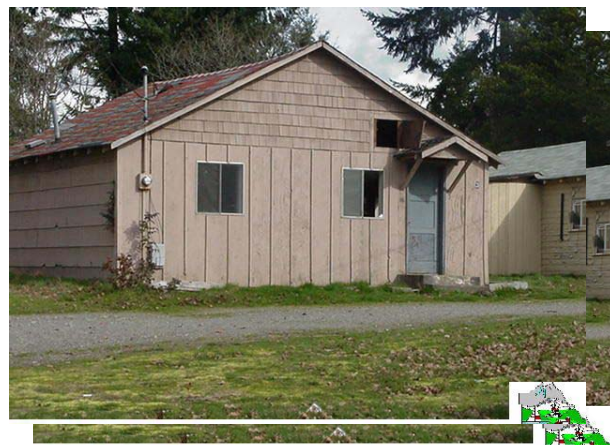
Low Quality Construction

Bedrooms:
Small
None to minimal closet space
1 small window to meet code
No family room
Laundry in basement, bathroom or enclosed porch
Electric baseboard or wall heaters
Lowest grade vinyl and carpets
Hollow core, lowest cost doors
None to very minimal, cheap trim
No wall texture
Minimal lighting and outlets
No extra features

Very plain and inexpensive
Post, pier, block or slab foundation
Plywood or T1-11 all sides
Low grade composition, hot mop, or rolled roofing w/low pitch

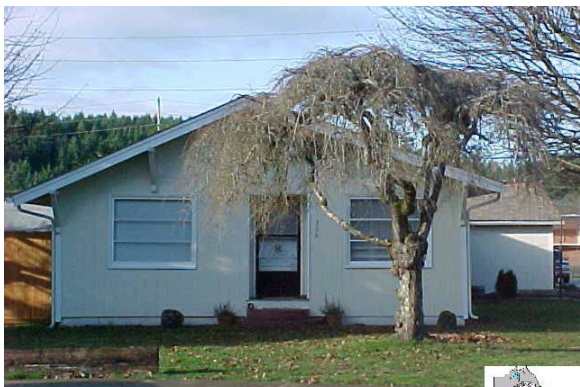
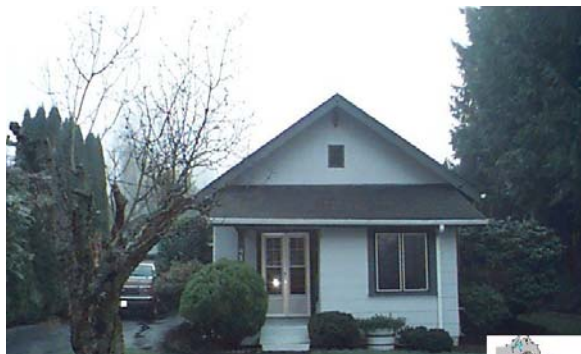
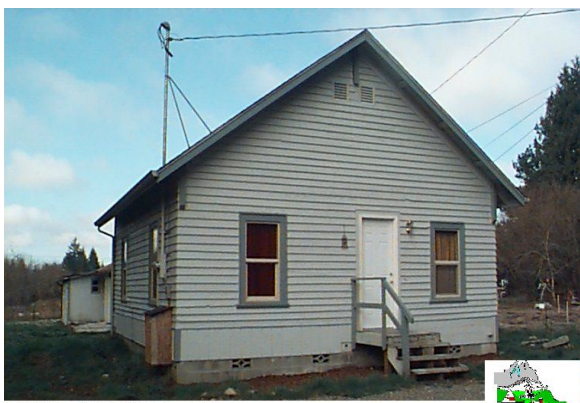
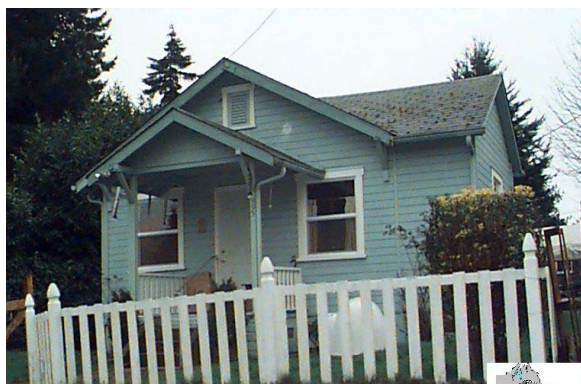
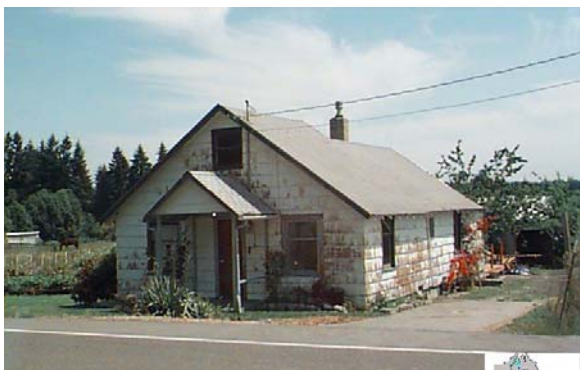
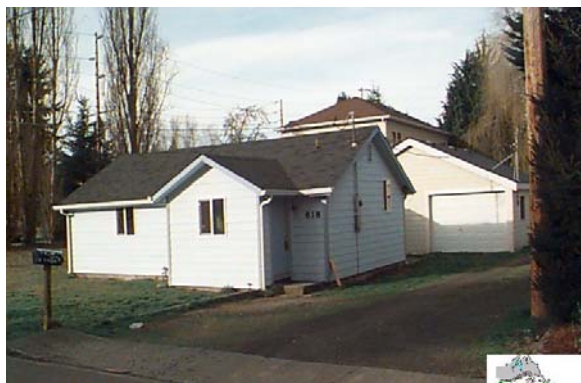
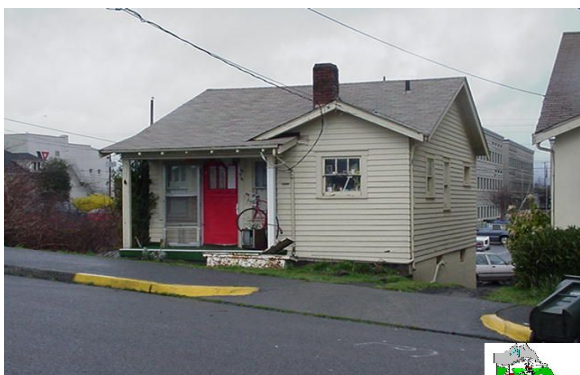
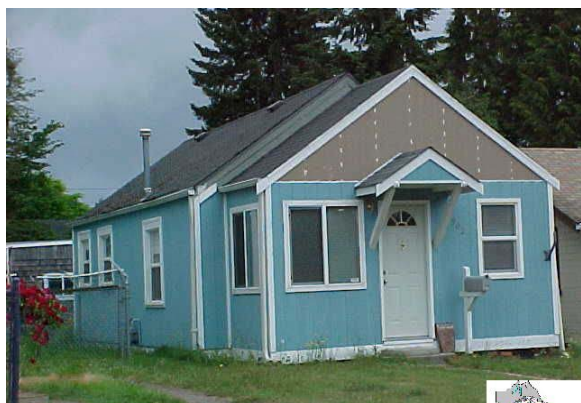
Fair Quality Construction (4 of 4)

Rectangular design
Mass produced
Meets minimum construction requirements
CC slab, 6-8" cc perimeter or cc block foundation
T1-11 all sides
Low grade comp, hot mop or rolled roofing w/low to medium pitch

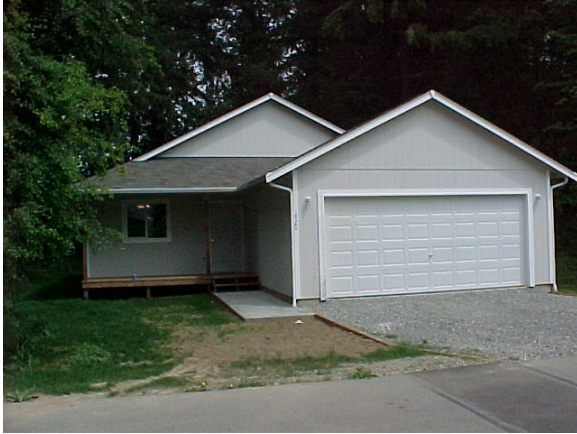
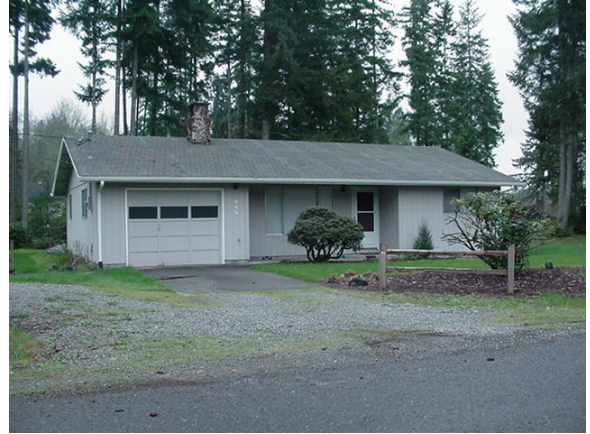
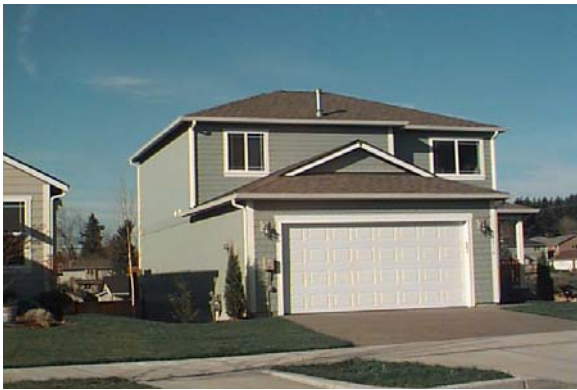
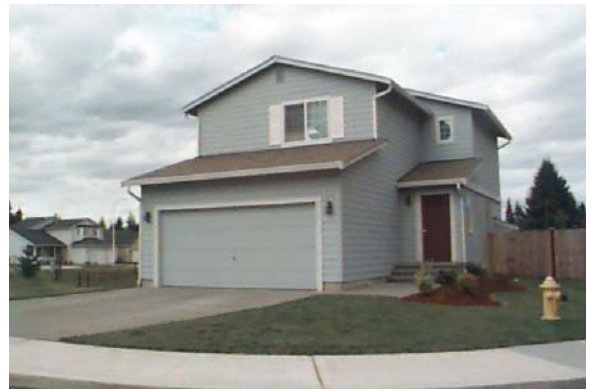
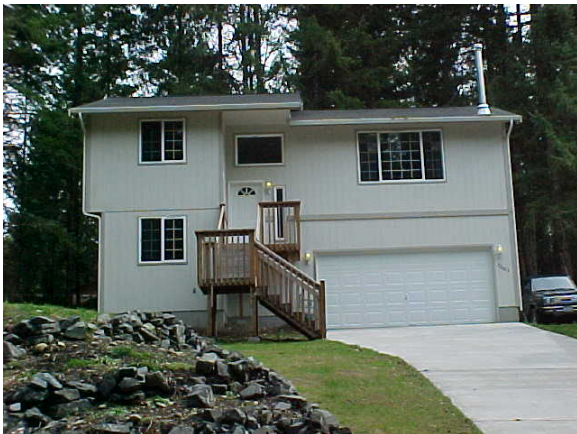
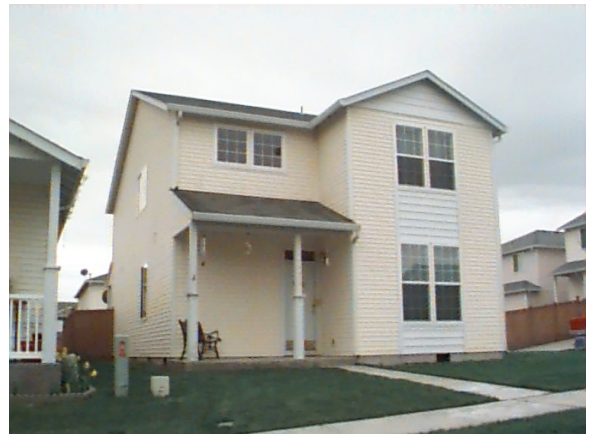
Fair+/Average- Quality Construction (1 of 4)

Rectangular design
Mass produced
CC slab, block or 6-8" cc perimeter foundation
T1-11 X4, possibly some lap on front
Low grade comp or metal, medium pitch roof

1-2 ½ Bathrooms:
¾ master bath
Formica counters
Vinyl flooring
Fiberglass tub/shower surround
Minimal lighting
Low cost fixtures
Bedrooms:
Standard size closet
1 window to meet code
No separate family room; living area may be enlarged to great room
Laundry in closet, laundry room, basement or garage w/no cabinets or laundry tub
Carpet and vinyl flooring
Hollow core wood or vinyl veneer. Older homes solid wood
Electric wall, baseboard or forced-air furnace
Inexpensive base and door trim
Simple wall texturing
Minimal light and outlets
No extra features

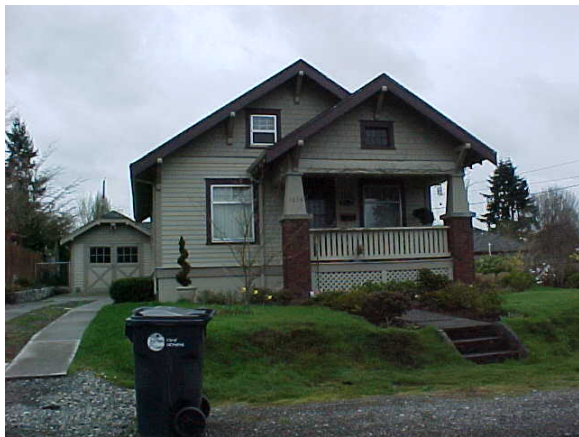
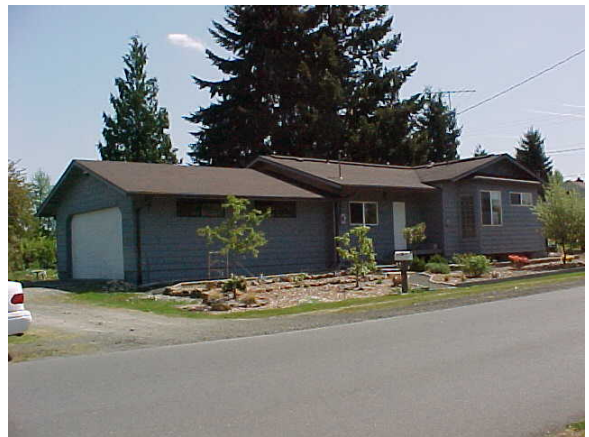
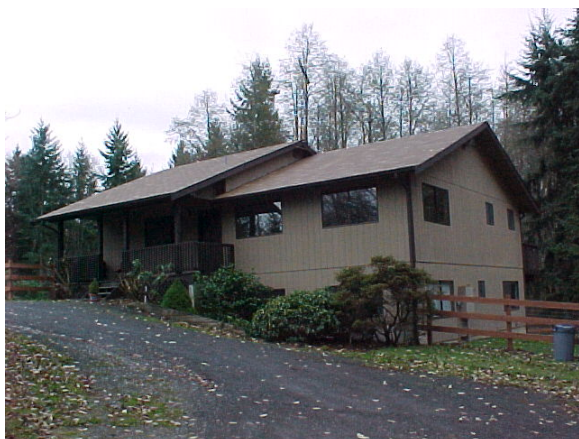
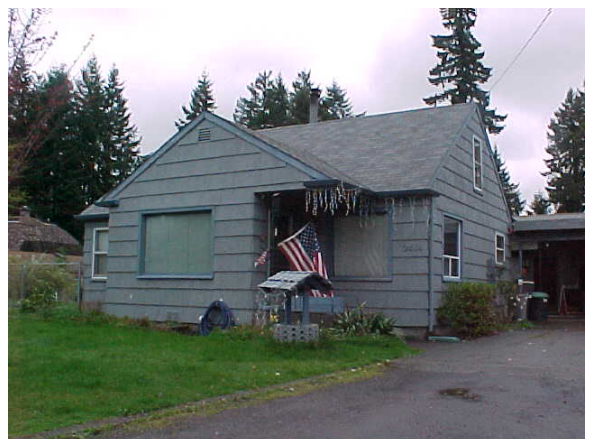
Average Quality Construction (1 of 3)

Rectangular design w/jog in front
Mass produced
Meets or exceeds minimum construction requirements
CC slab or 8" cc perimeter foundation
Newer construction w/lap siding on front and T1-11 on other 3 sides. Prior to 1980 w/same quality siding all around

Master w/2 sinks and shower or tub/shower combo
Main bath tub/shower w/fiberglass surround
Standard fixtures
Vinyl flooring
Adequate lighting
Bedrooms:
Standard closet
1 window to meet code
Family room off kitchen
Laundry in closet, laundry room, basement or garage w/no cabinets or laundry tub
Carpet, vinyl, minimal hardwood flooring
Hollow core wood or vinyl veneer. Older homes will have solid wood doors
Electric wall or forced-air furnace. Older homes upgraded to central heat, 60-70's bb electric
Inexpensive base and door trim
Knock down wall texture
Average lighting and outlets
No extra features

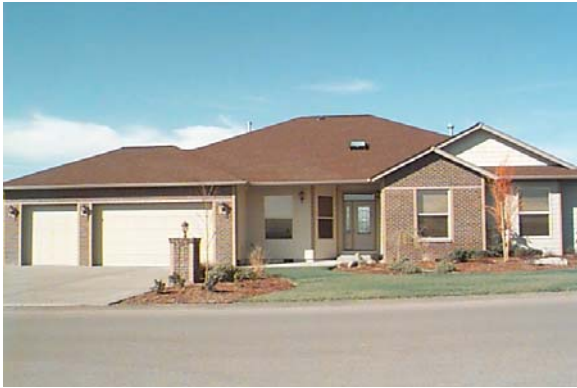
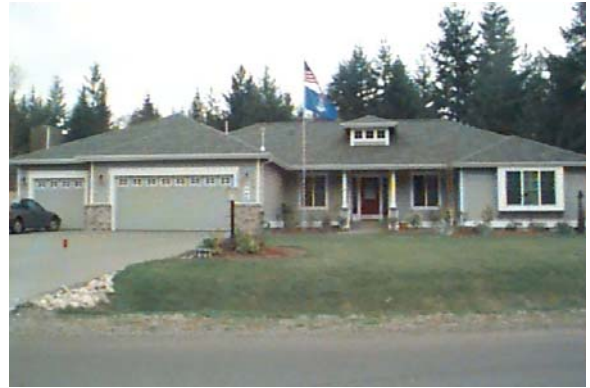
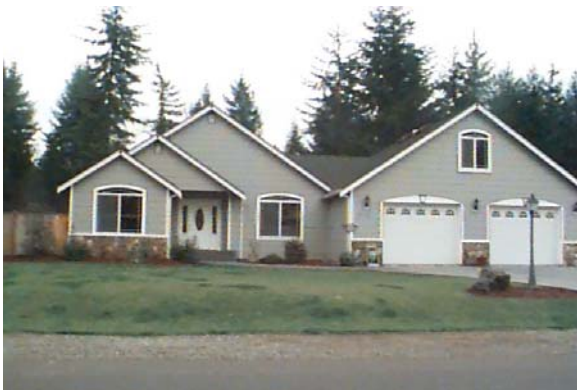
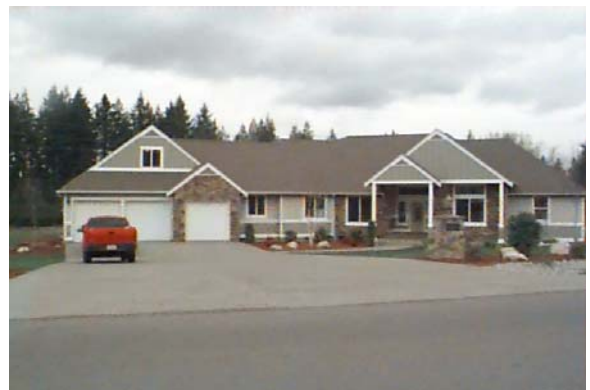
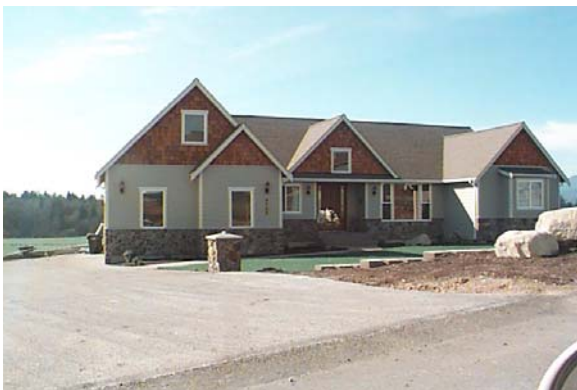
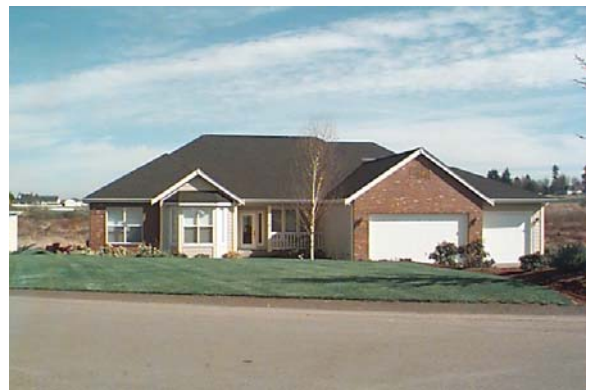
Good Quality Construction (1 of 4)

Multi jogged along front, sides or back
8" cc perimeter foundation
Lap siding all around w/front having approx 30% brick, stone or stucco
Very good grade arch comp, wood shingle or tile, more varied roofline. Older homes will have steeper pitch w/good quality comp, shake or tile roof

Large, open entryway and hallway, hardwood or tile flooring
Windows w/complete wood surrounds. Non updated older homes will have some leaded windows
Stairwells:
More open and decorative
Railing systems w/banister
Simplest wood spindle balusters
Gas or pellet burning fireplaces w/marble tile facing, wood mantel, tile hearth
Formal dining room w/coved ceilings or wainscot
Kitchen:
Medium grade wood cabinets
Upgraded countertops of corian, tile, concrete
Island w/cook top
Good fixtures
Phone desk and breakfast bar counters
Eating area adjacent
Hardwood or tile flooring

Larger, more decorative non standard windows
2-3 car garage, outside entrance door, interior tape, textured and painted, windows in door
Trim on 3+ sides
Enclosed soffits
Bay windows will have cc foundations
Decorative entry door w/side-lights

2-3 baths:
Master bath w/2 sinks and separate soaking tub, tiled shower
Main bath w/2 sinks
Good fixtures
Tub surrounds and counters tile
Flooring hardwood or tile
Master bedroom will have walk in closet
Family room off kitchen or finished bonus room over garage
Laundry room w/sink and cabinet
Good grade carpet, vinyl, hardwood and tile flooring
Solid core doors
Forced-air furnace w/heat pump or hot water radiant
Wood trim, more decorative, full wood wrapped windows and doors, some wainscot, mitered corners
Wallpapering & textured walls w/some alcoves
Decorative, layered 9' ceilings on main level, vaulted or cathedral in entry
Recessed lighting, ample number of outlets
Minimal extra features
Some extra features

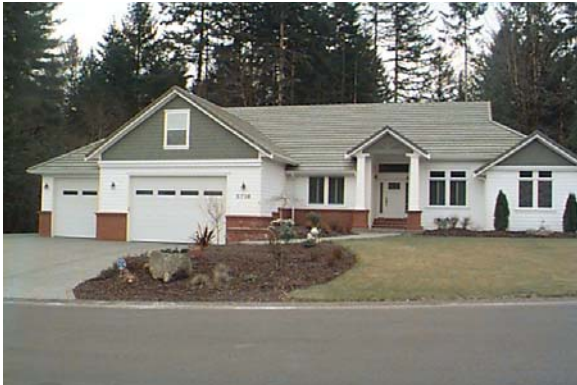
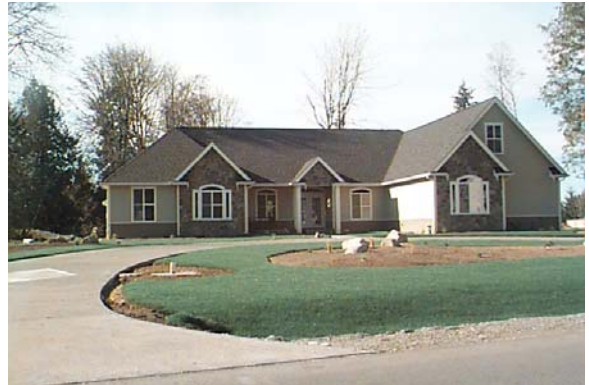
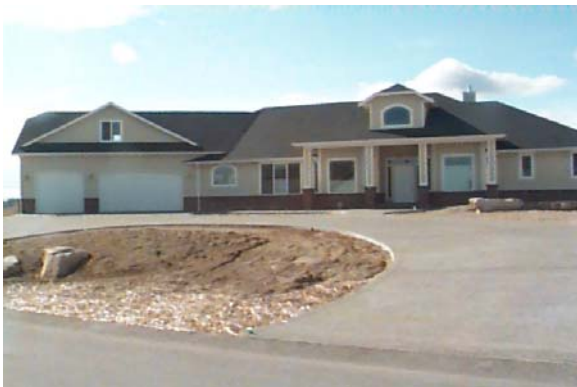
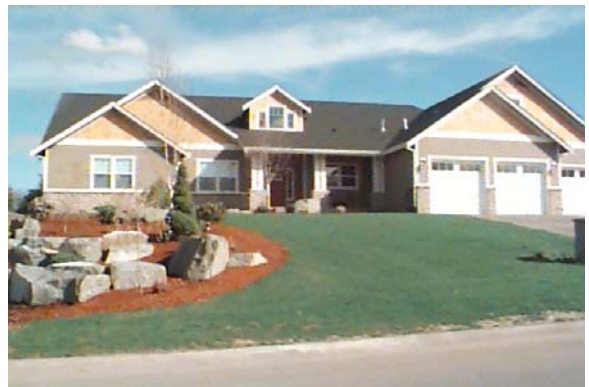
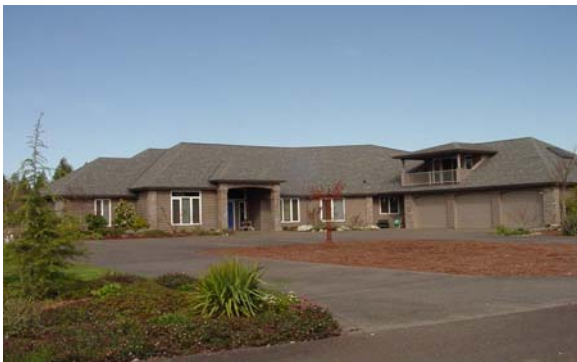
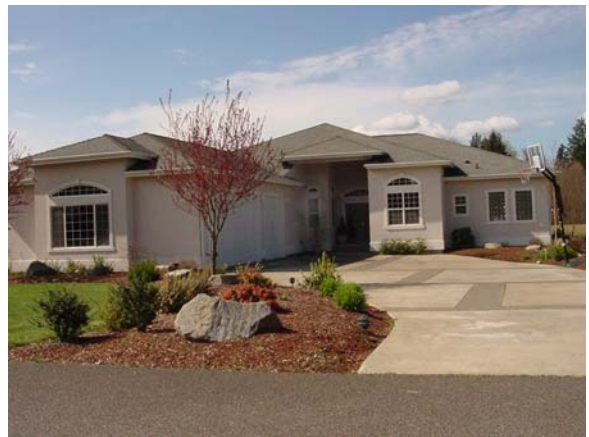
Good+ Quality Construction (1 of 4)

Multi jogs along front, sides and back
8" cc perimeter foundation
Lap siding all around w/extensive use of brick, stone or stucco
Enclosed eave/soffits
Very good grade arch comp, wood shingle or tile, high pitched, more varied roofline.
Older homes will have steeper pitch w/good quality comp, shake or tile roof

Large, open entryway and hallway, hardwood or tile flooring, entry becoming more decorative and expansive
Windows w/complete wood surrounds. Non updated older homes will have some leaded windows
Stairwells:
More open and decorative
Railing systems with banister
Simplest wood spindle balusters
Gas or pellet burning fireplaces w/marble tile facing, wood mantel, tile hearth
Formal dining room w/coved ceilings or wainscot
Kitchen:
High grade wood cabinets
Upgraded countertops of ceramic or granite tile, or corian
Island w/cook top
Expensive fixtures
Phone desk and breakfast bar counters
Eating area adjacent
Hardwood or tile flooring

Larger more decorative and non standard windows, more in number
2-3 car garage, outside entrance door, interior tape, textured and painted, exterior windows and windows in door
Trim all around
Bay windows will have cc foundations
Enclosed soffits
Decorative entry door w/side-light surrounds

2-3 baths:
Master bath w/2 sinks and separate soaking tub, tiled shower
Main bath w/2 sinks
Expensive fixtures
Tub surrounds and counters tile
Flooring hardwood or tile
Master bedroom will have walk in closet and some built ins
Family room off kitchen or finished bonus room over garage
Laundry room w/sink and cabinets
Good grade carpet and ample amount of hardwood and tile flooring
Solid core doors
Forced-air furnace w/heat pump or hot water radiant
Wood trim, more decorative, full wood wrapped windows and doors, some wainscot and crown molding, mitered corners
Textured walls w/some alcoves and wallpapering
Decorative 10' ceilings on main level, vaulted or cathedral in entry
Recessed and special lighting, expensive fixtures, more than ample number of outlets

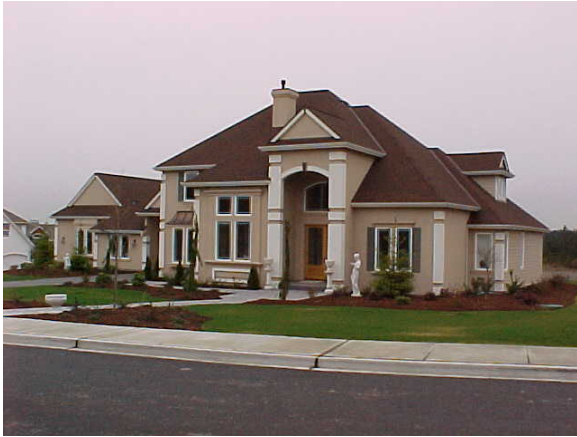
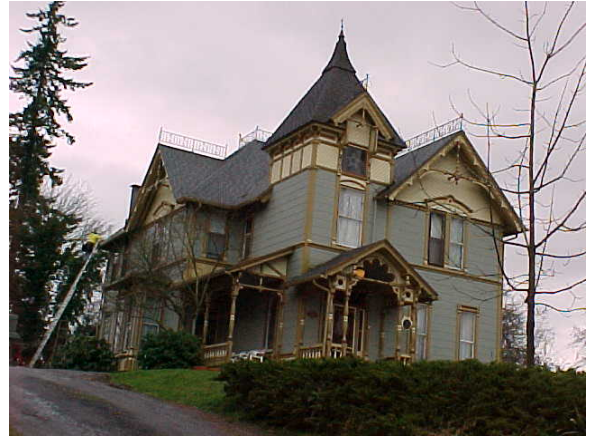
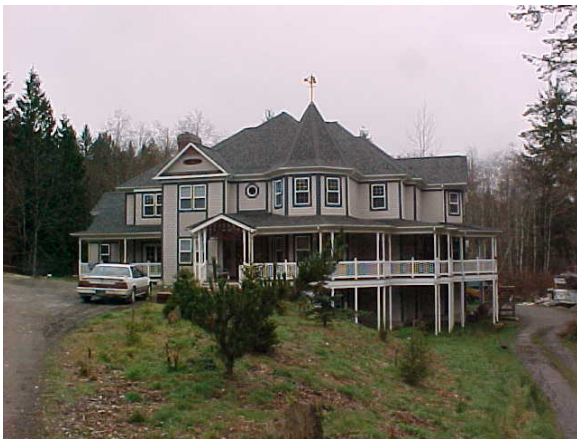
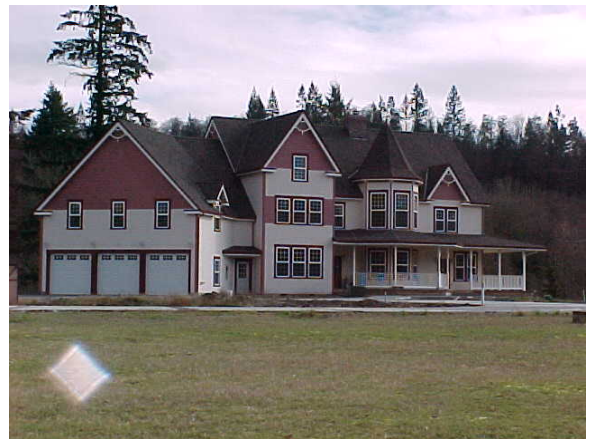
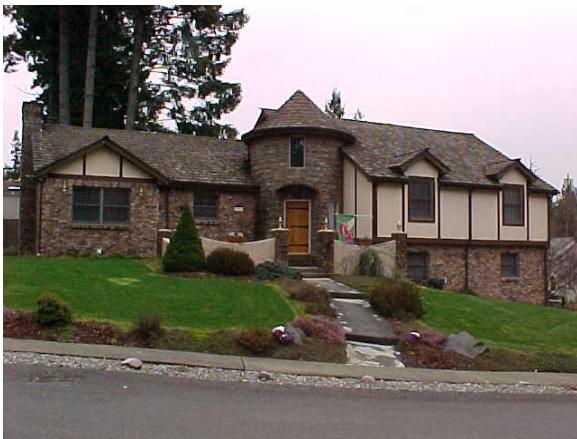
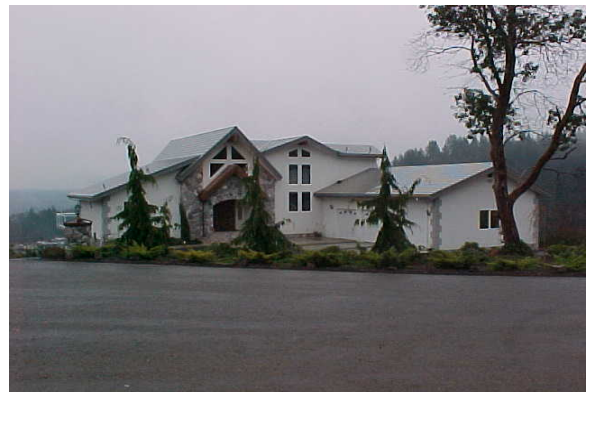
Excellent Quality Construction (2 of 4)

Custom designed
8" cc perimeter foundation
Expensive siding on at least 3 sides w/a large amount of brick, stone or stucco on the front
Tile, wood shake/shingle or slate roofing w/very complex, steep pitch roof design
Larger more ornate and non standard, excellent quality triple paned windows, very numerous, some custom made

3 car garage, outside entrance door, windows, interior finished to same level as house
Extensive trim all around
Bay windows will have cc foundation
Enclosed soffits w/lighting
Large eaves and overhangs
Double entry, ornate doors w/side-light surrounds
Use of some stained or other decorative glass

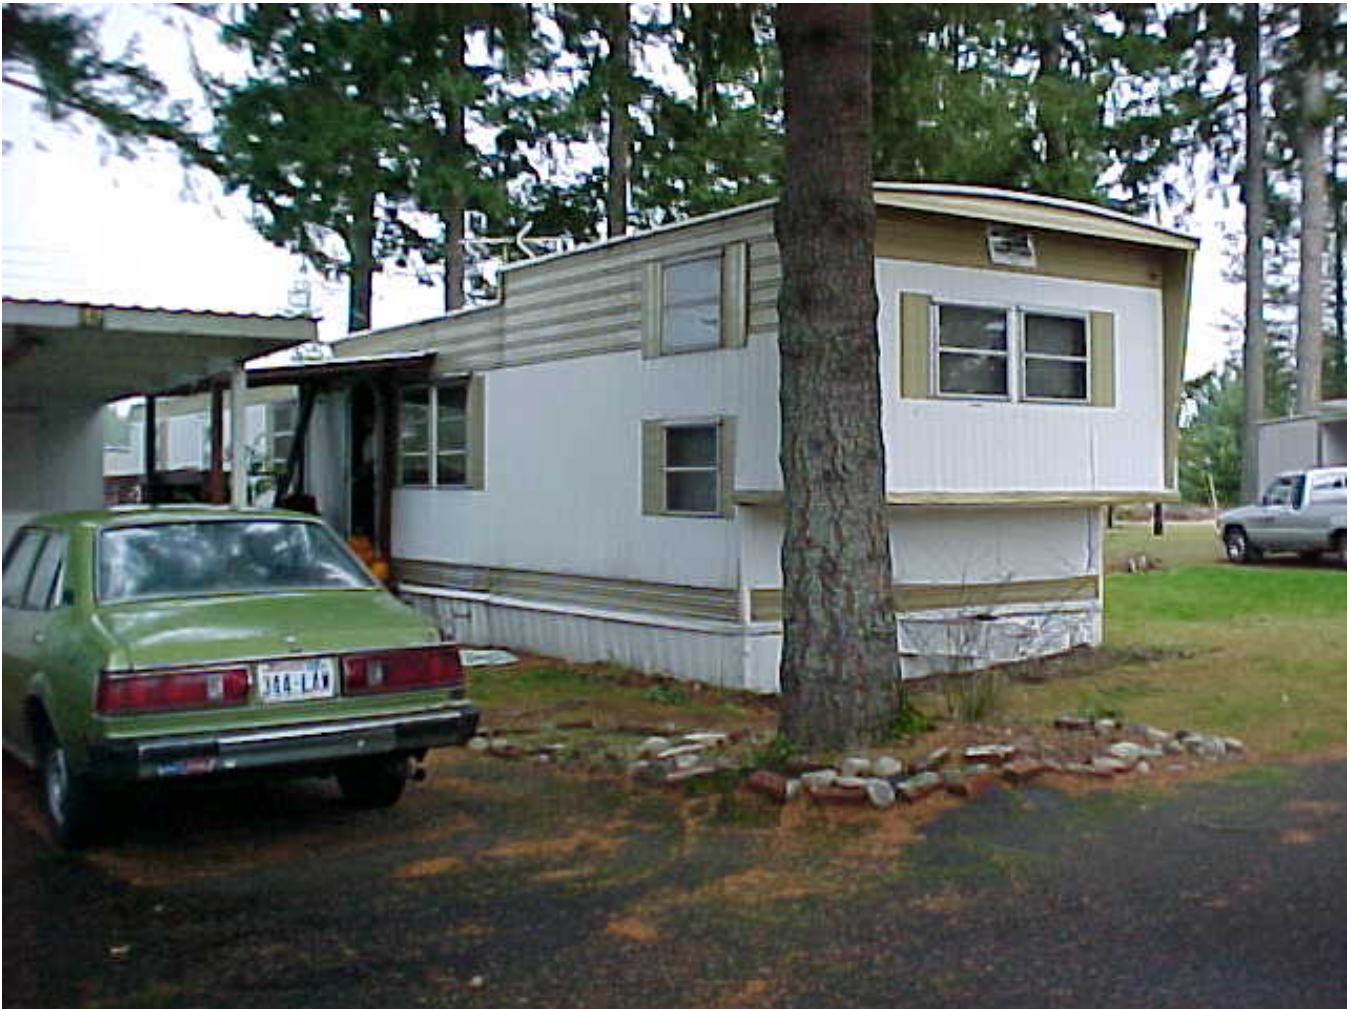
Low Quality, Average Condition

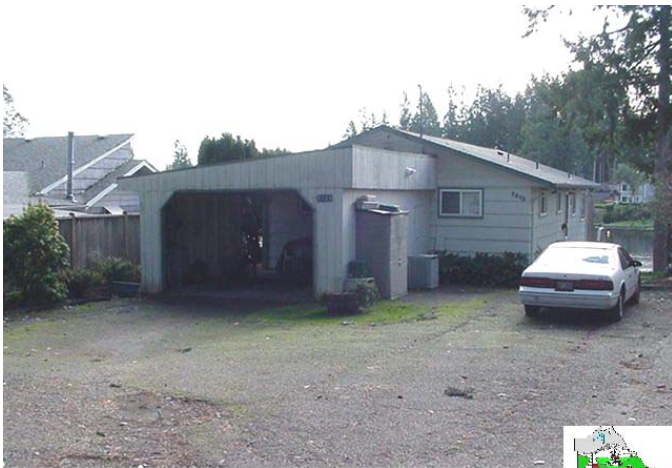
AC — Carport
