ASSESSMENT DATA DEFINITIONS

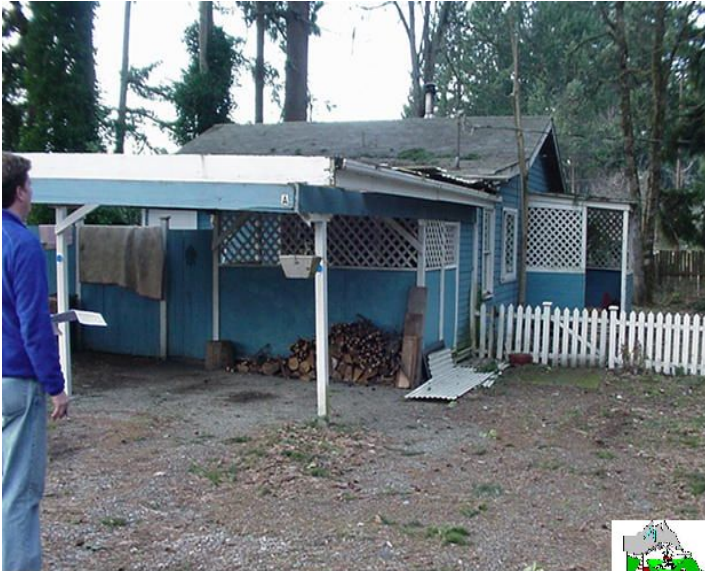
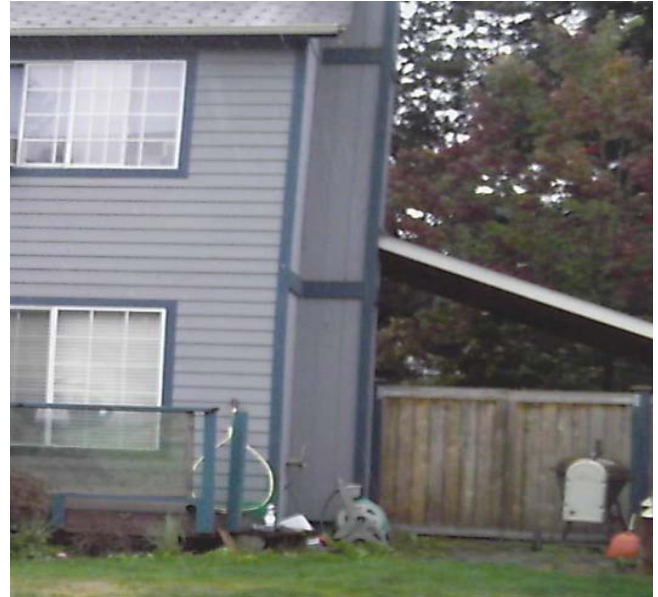
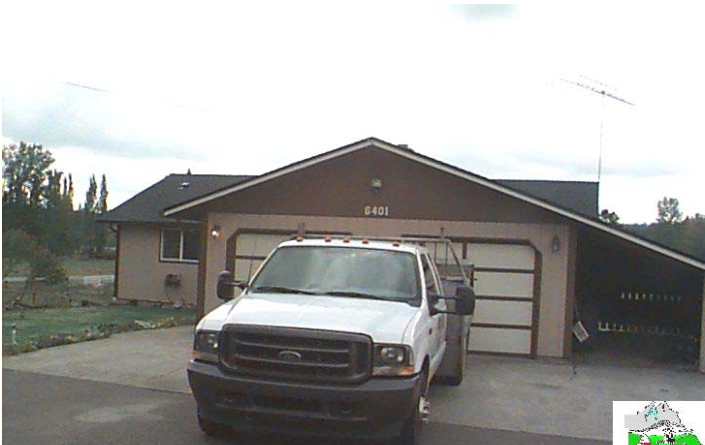
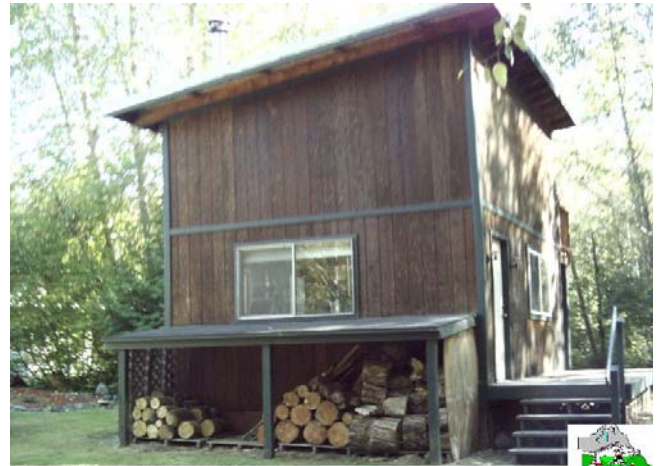
COV — Cover

An open or partially closed covered area usually formed by a roof projecting from the side of a building. Covers generally will have a dirt or gravel. The difference between carports and covers would be the concrete flooring, size.

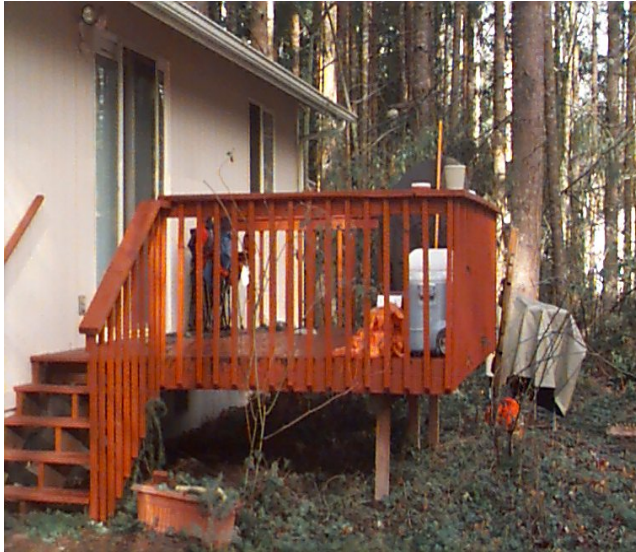
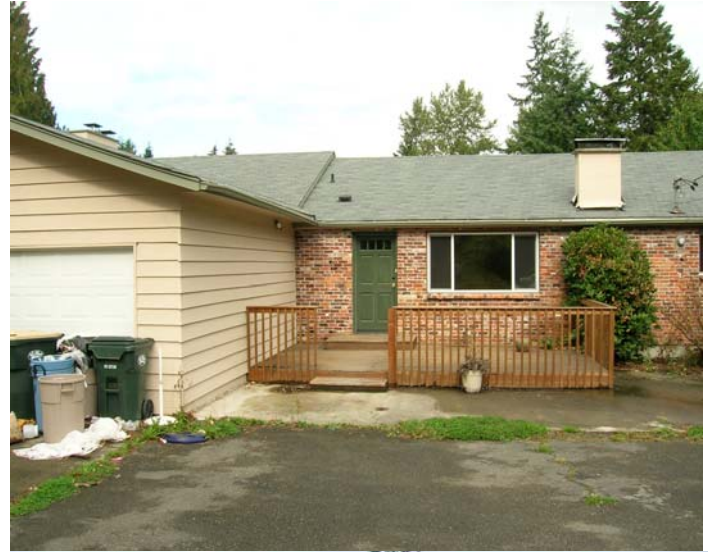
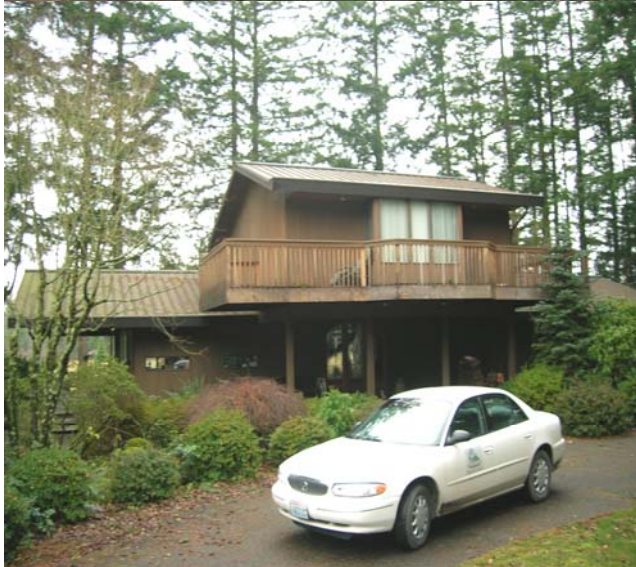
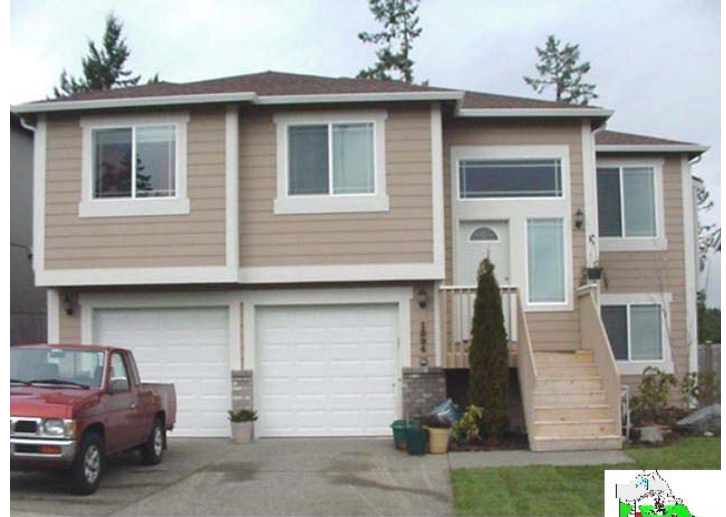
WD — Wood Deck

An area constructed with wood, wood products or composite products (Trex) adjoining the residence. Wood decks can also be raised and will have support posts.

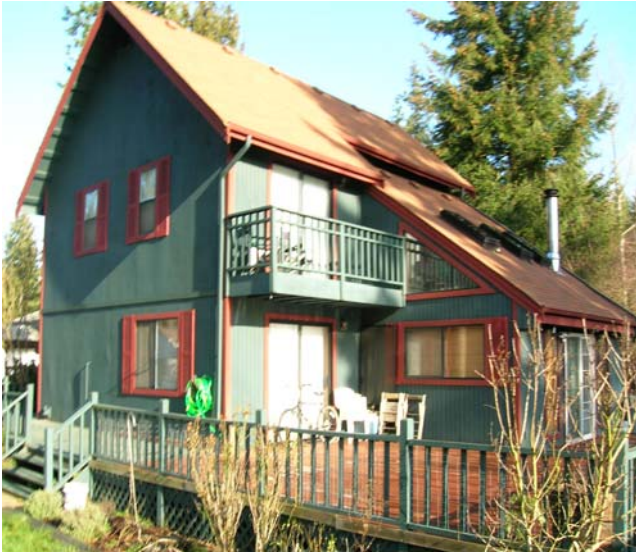
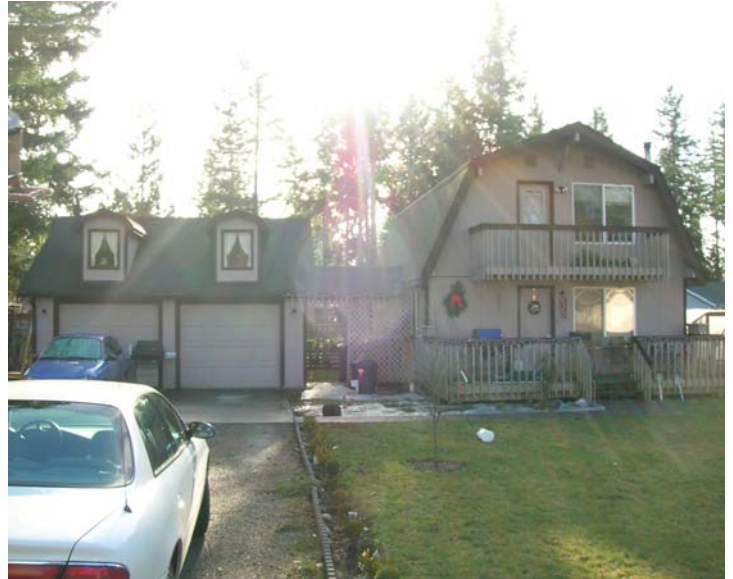
BAL — Balcony

A balcony is a small railed elevated platform projecting from the wall of the residence. These would not have support posts. The area below the balcony should not be labeled as covered. The area below the balcony should be labeled according to its use such as patio or wood deck but should not be coded as a covered or open porch.

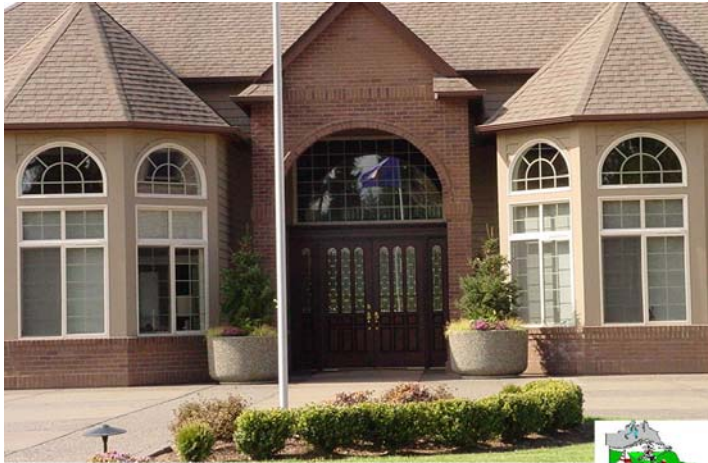
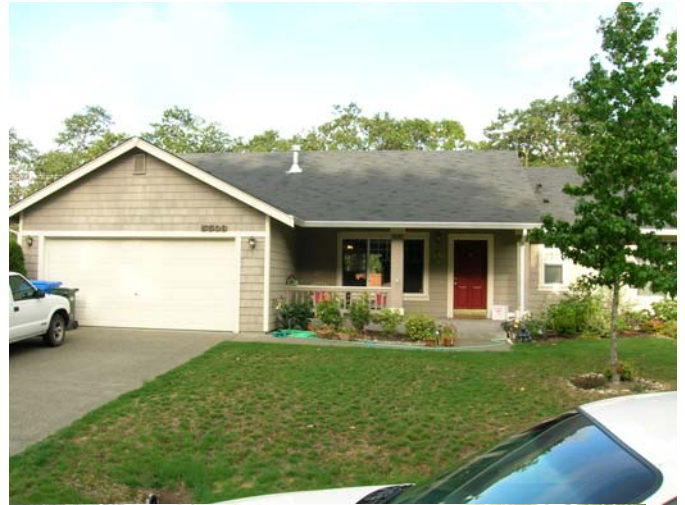
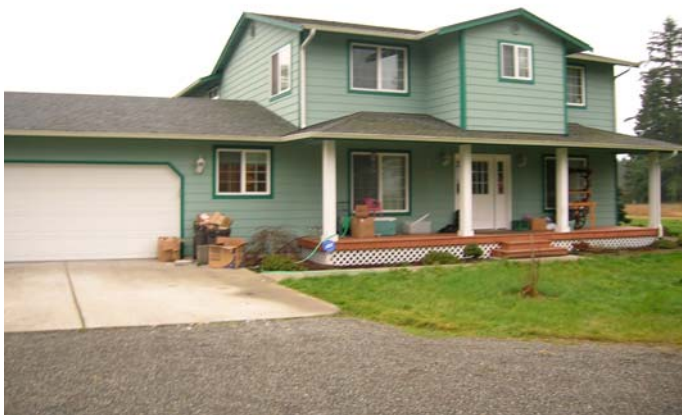
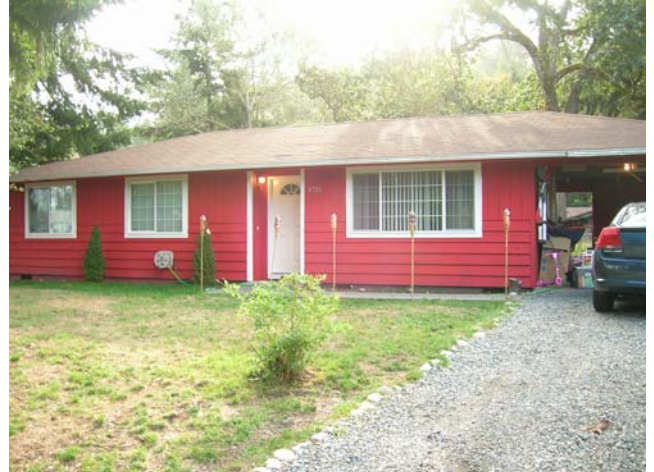
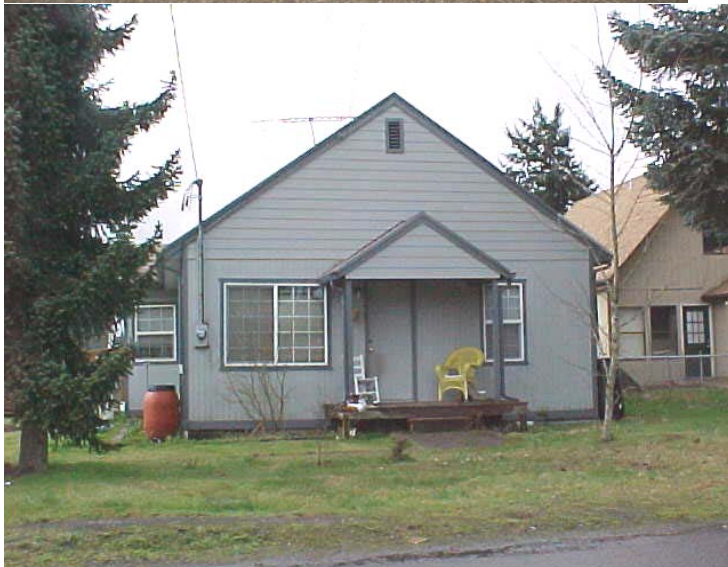
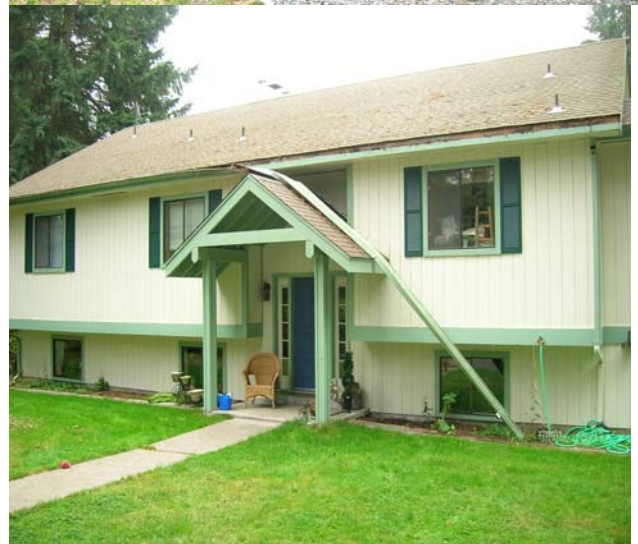
CP— Covered Porch

A covered porch is an extension to the roof line and finished to the quality of the residence. It would typically include a ceiling. The covered porch would have either a concrete slab or wood decking for its base and may or may not have supporting posts. Small entryways that are set back into the house where the roof extends over it are to be coded as covered porches.

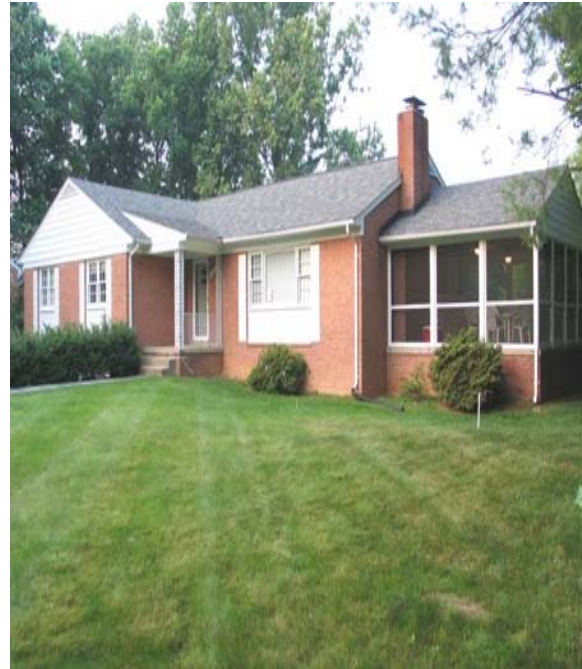
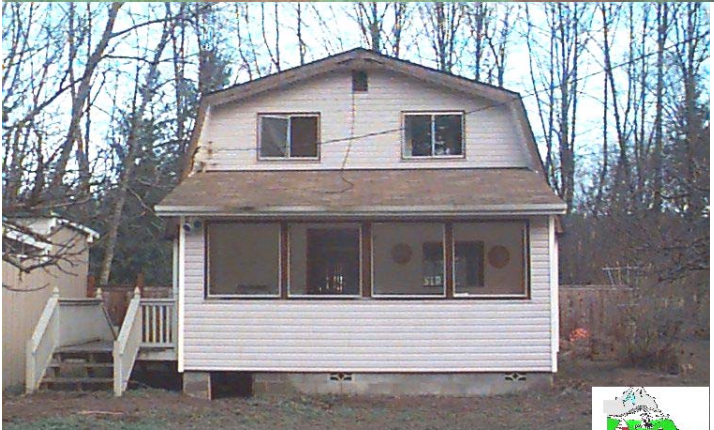
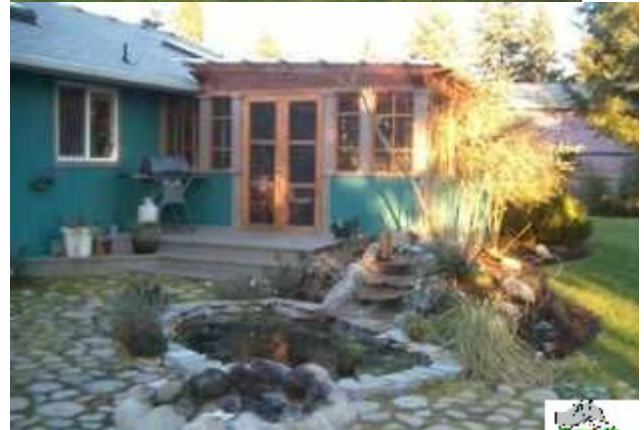
EP— Enclosed Porch

An area enclosed by three sides and separate from the main dwelling unit but attached to the residence.

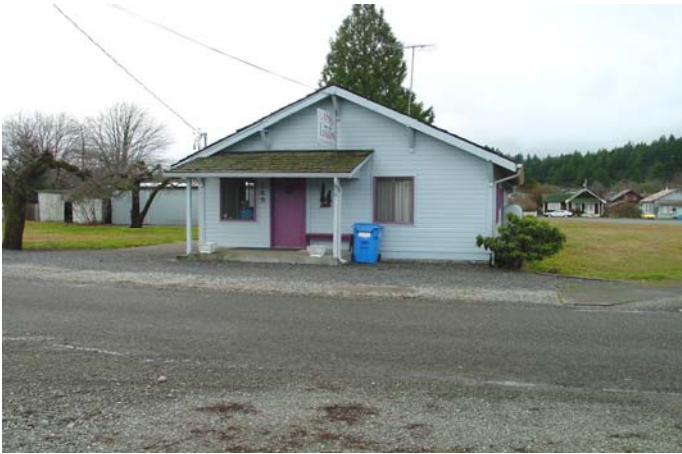
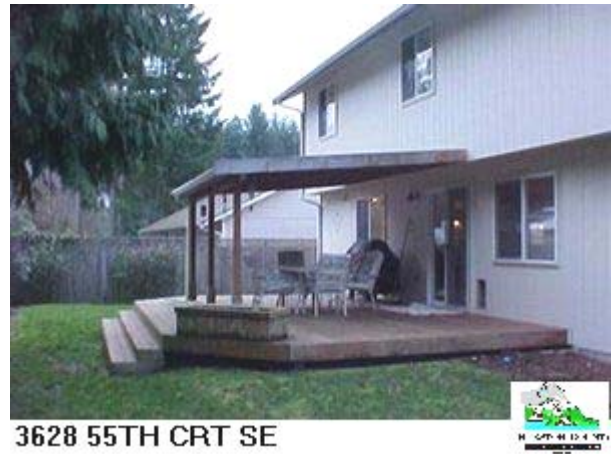
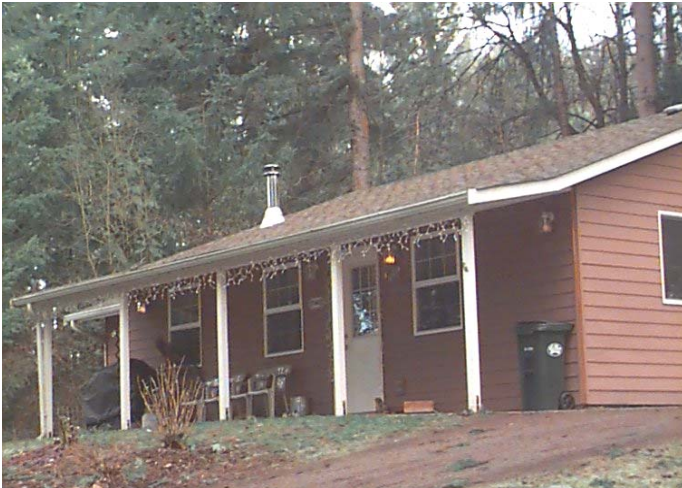
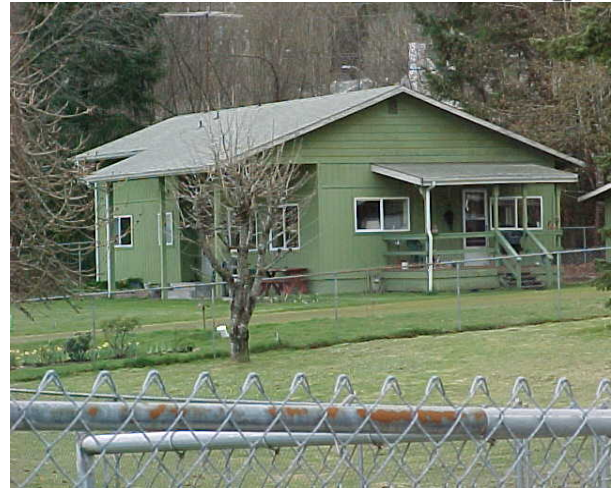
OP— Open Porch

An open porch would include a roof that is of lesser quality than the finish of the residence. It would typically not include a ceiling. The roof would typically have been added after the construction of the residence or would be attached to the side of the residence. These open porch roofs often resemble shed type roofs. The open porch would have either a concrete slab or wood decking for its base and would have supporting posts. An open porch should not be coded or sketched as a patio or deck and separate cover.

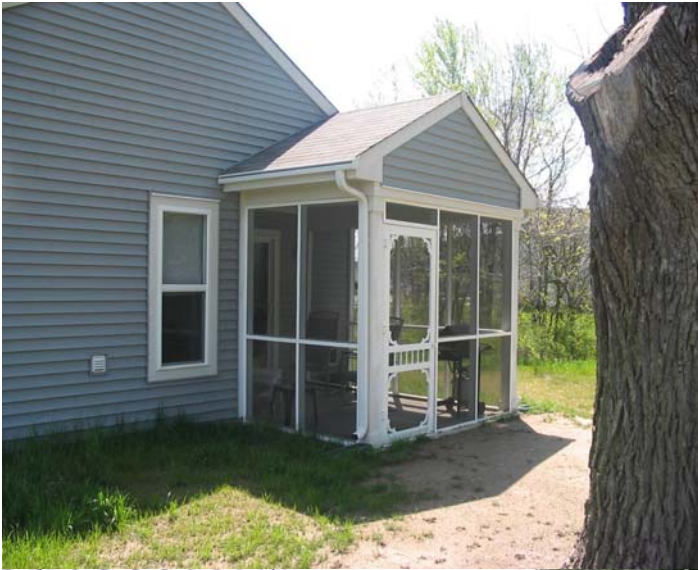
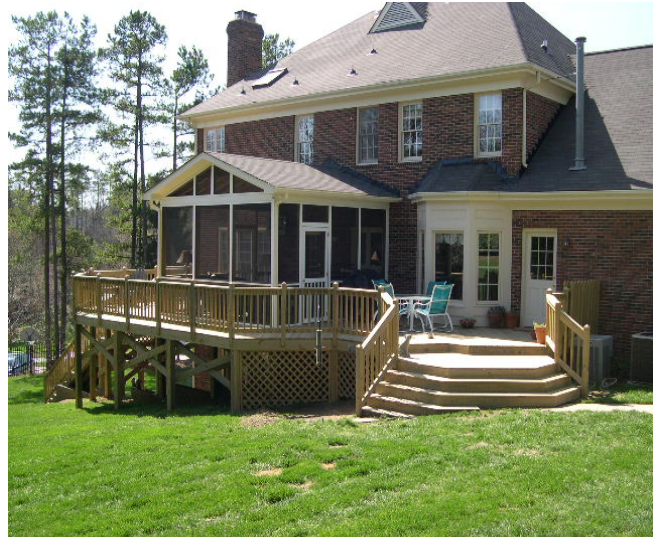
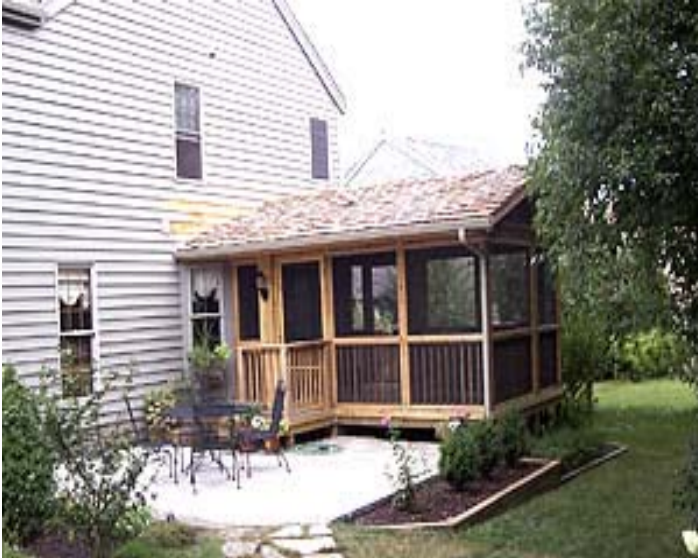
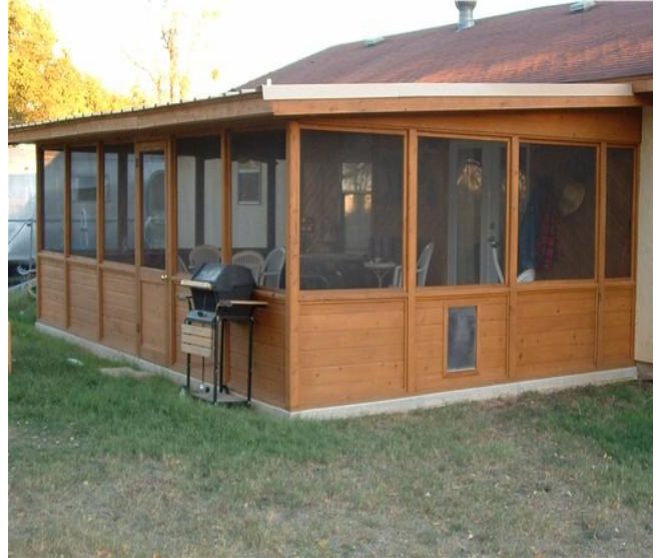
SP— Screened Porch

Similar to an enclosed porch yet the exterior walls are made from screen or some other product that allows air to flow through the porch.

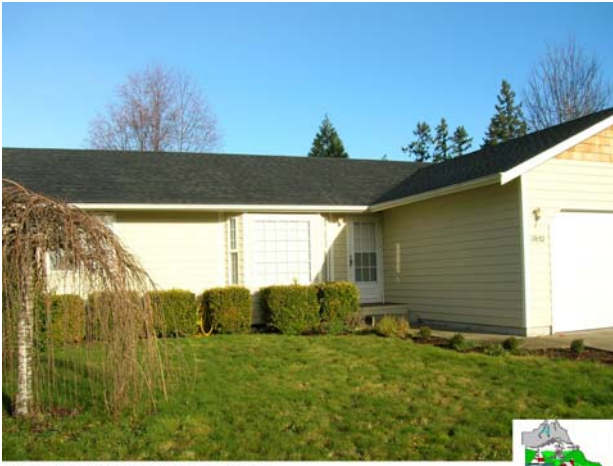
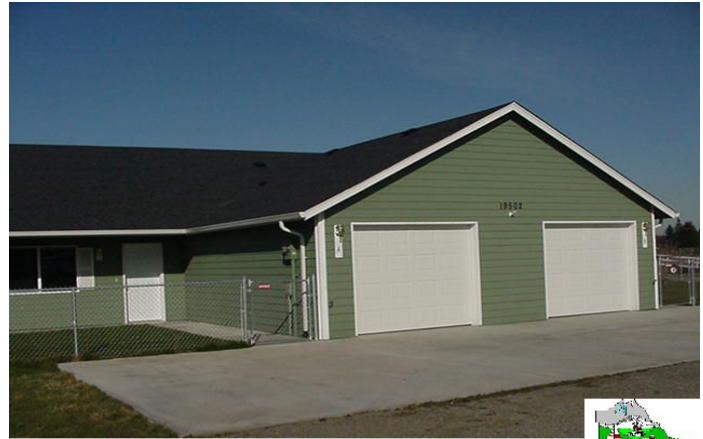
Stoops

There is no code or pricing for these attached structures. They are typically the concrete steps at the front or back entrance to the house that sit under the eave. They can be coded and sketched as a patio if greater than 5' by 5'.

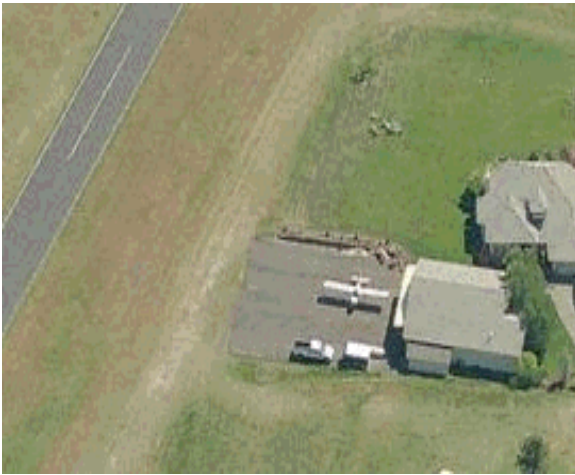
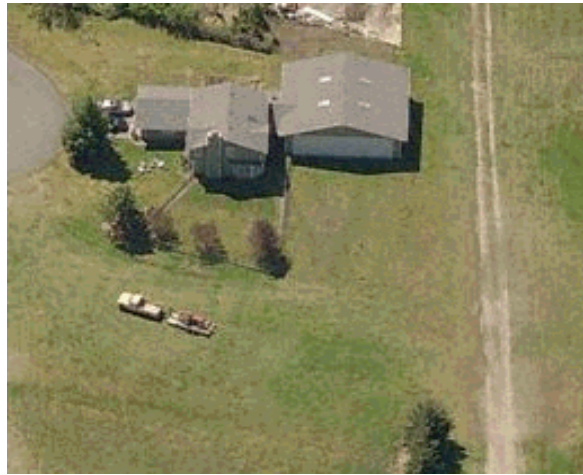
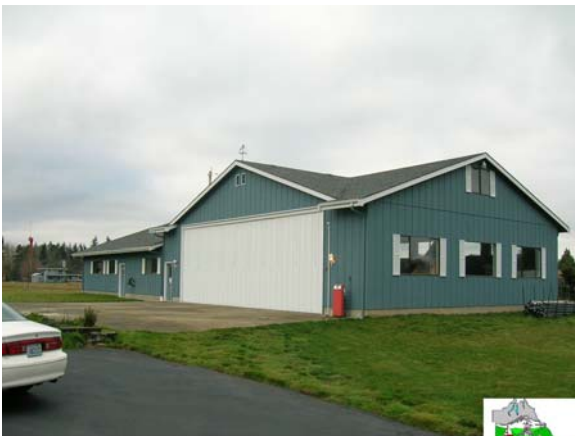
APH - Residential Aircraft Hangar

Hangars are buildings with one large door, and are used for housing and servicing airplanes. They will usually be located adjacent to a private airstrip. Hangars are all one cost rate.

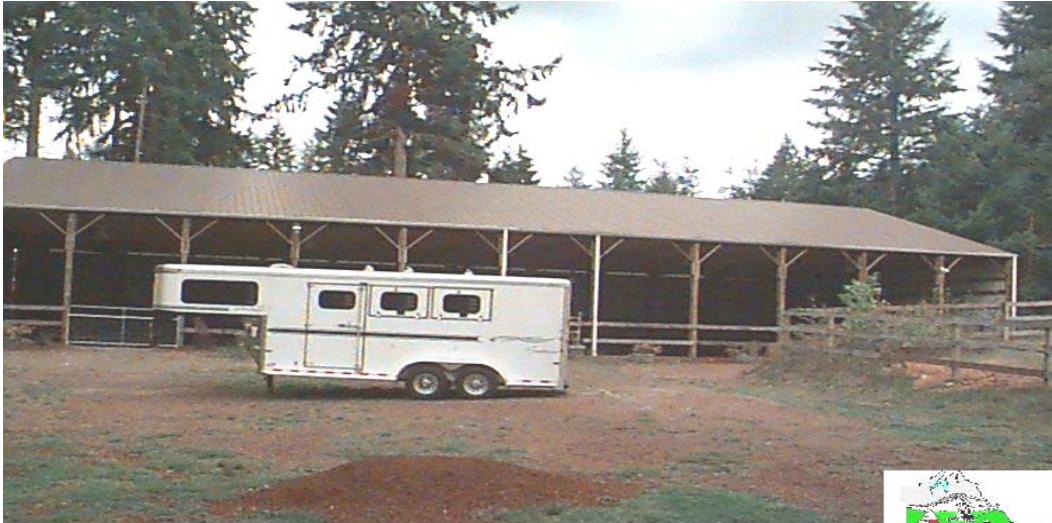
Fair Quality Arena

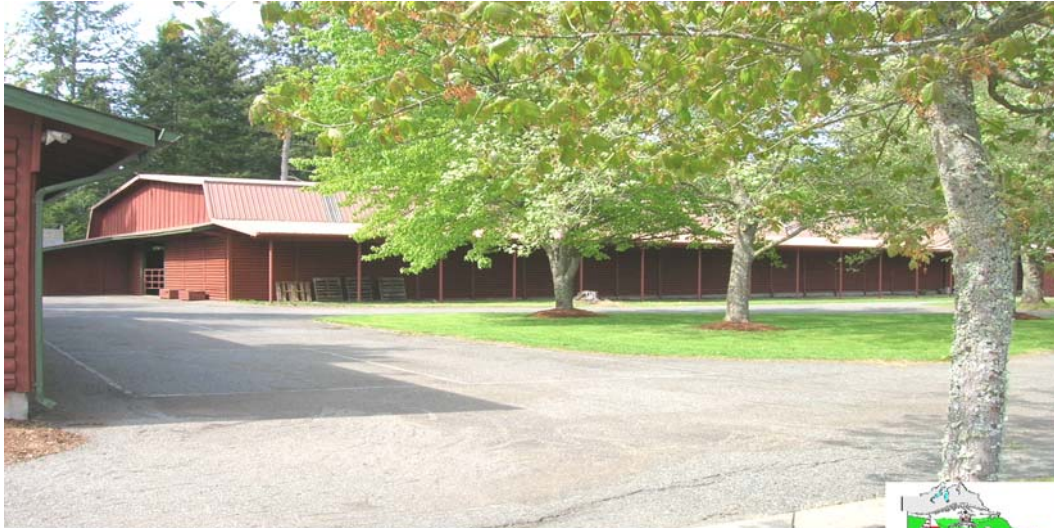
Very Good Quality
Arena

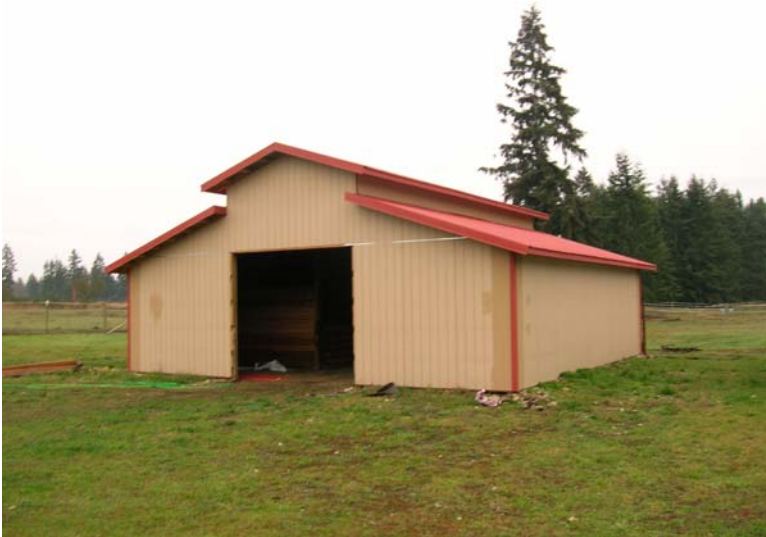
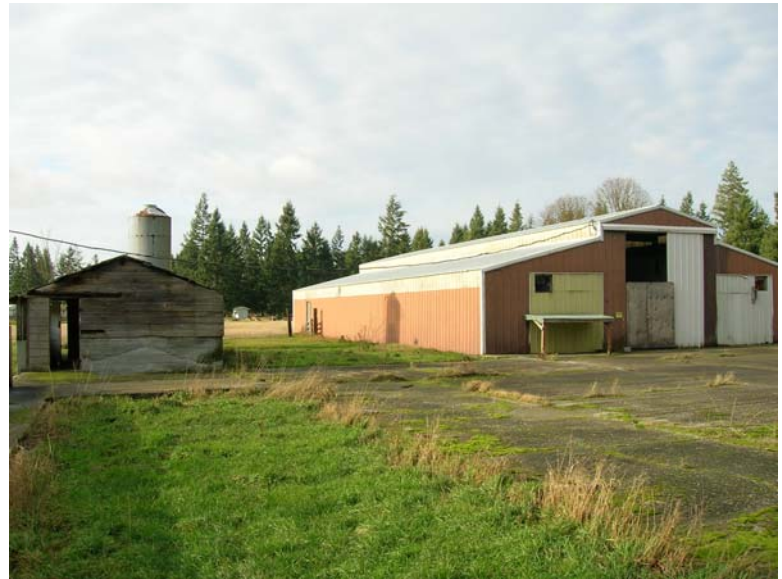
Average Quality
Barn No Loft

BAR-no loft barn

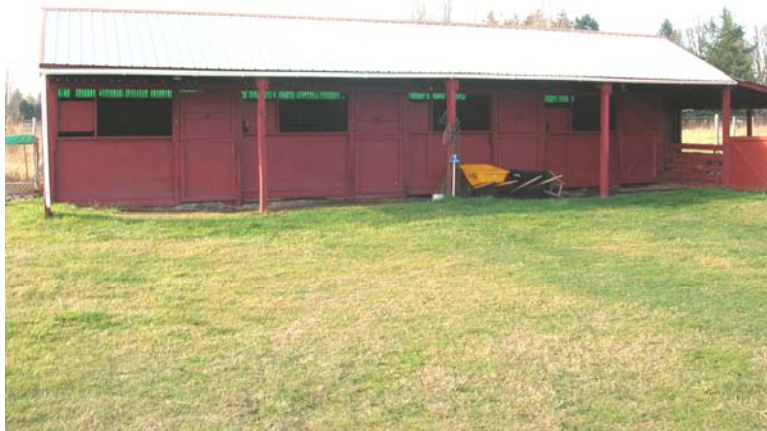
Stables are characterized by stalls for the boarding of horses or other animals. Essentially they are fully or substantially finished barns, and may include stalls, tack room, loafing and storage areas.

Low Quality Hobby Stable

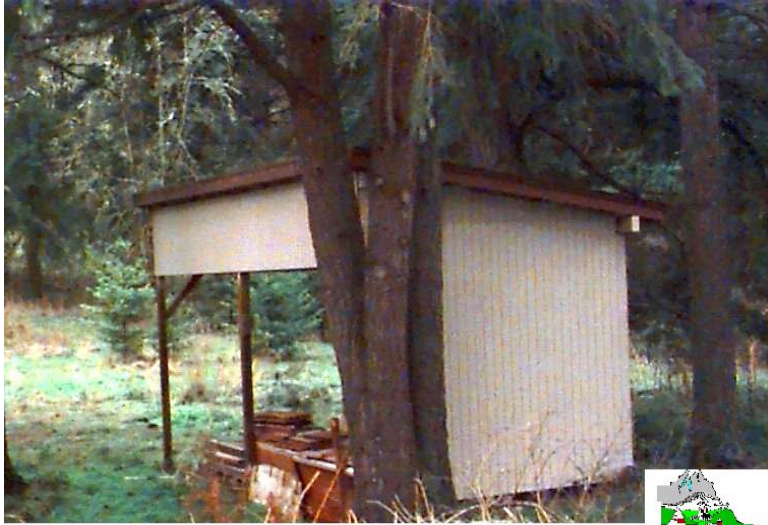
Loafing Sheds are open faced structures that are usually three sided, primarily used for storing hay or other material, or as a temporary animal shelter.

Low Quality
Loafing Shed

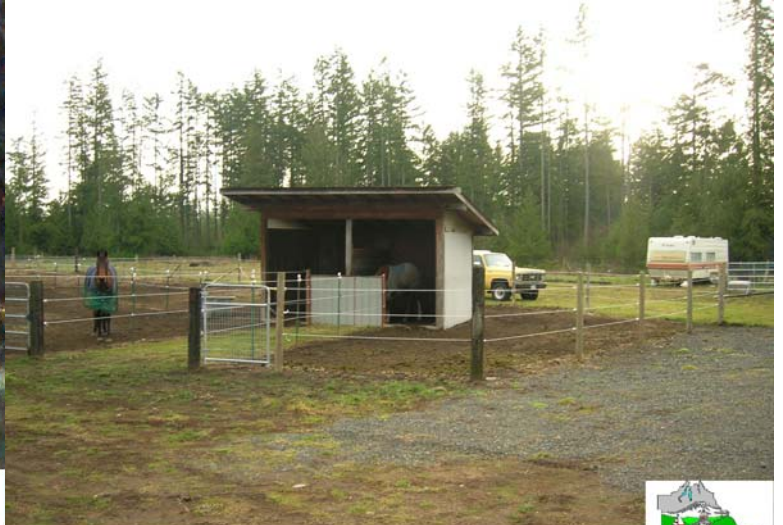
Fair Quality
Loafing Shed

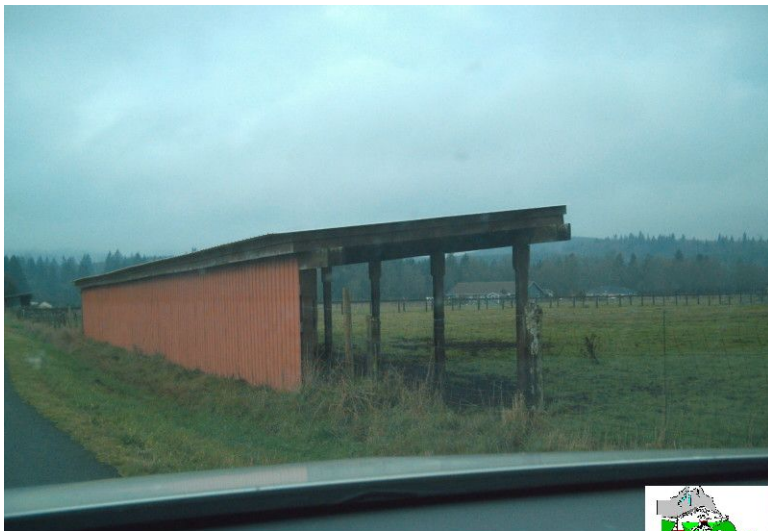
Average Quality
Loafing Shed

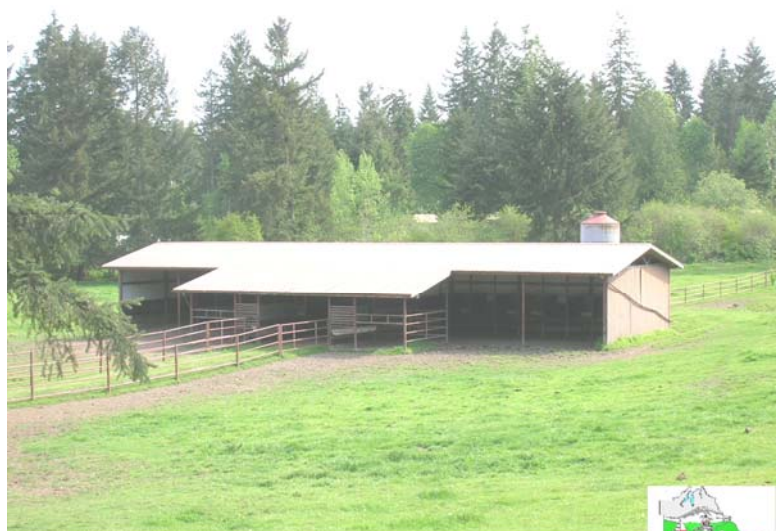
Good Quality
Loafing Shed

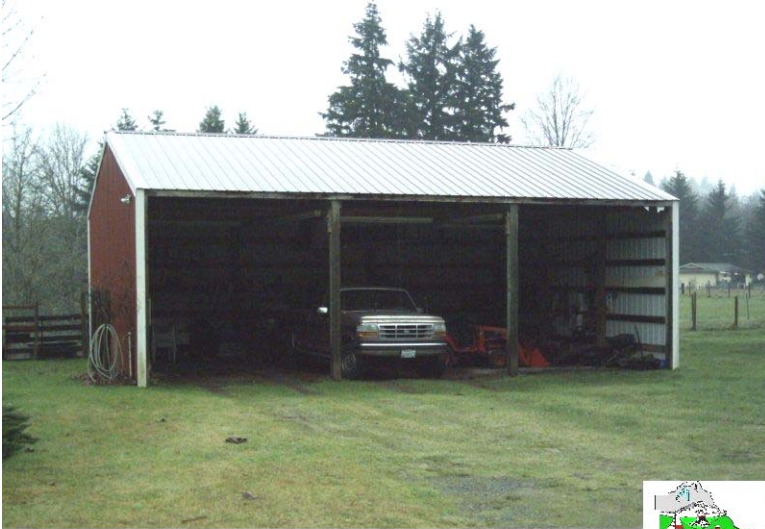
Machine Sheds are three sided structure, similar in appearance to loafing sheds, but larger and whose primary purpose is to shelter equipment and other machinery.

Fair Quality
Machine Shed

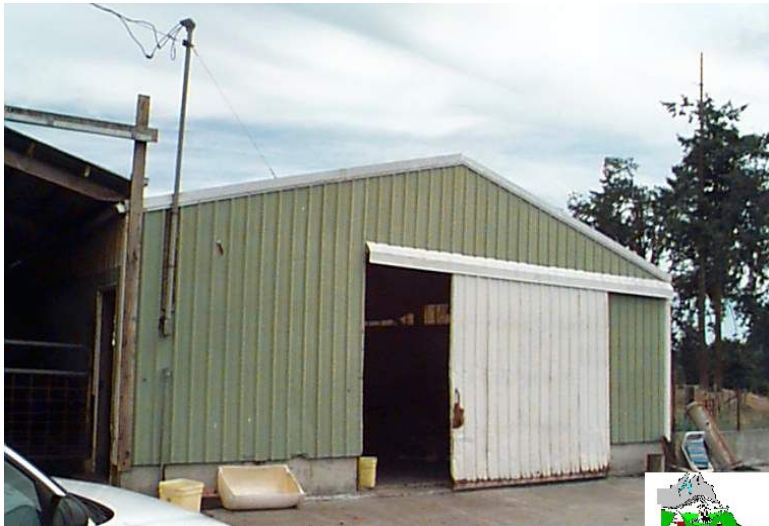
Low Quality
Pole Building

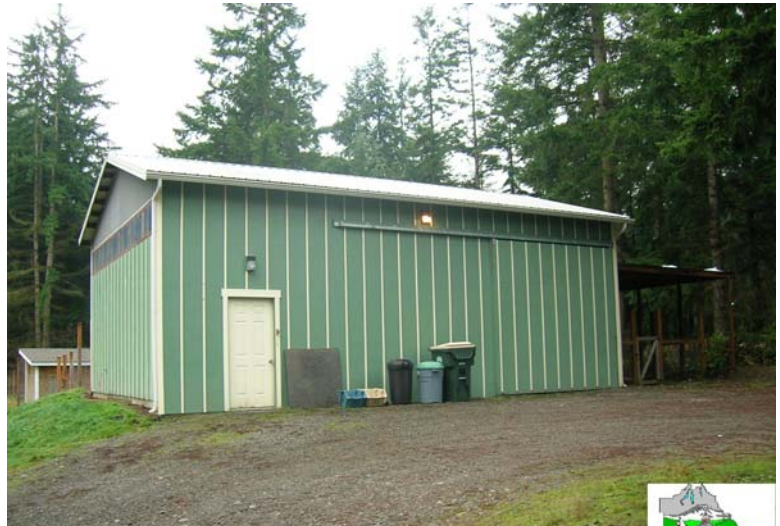
Fair Quality
Pole Building

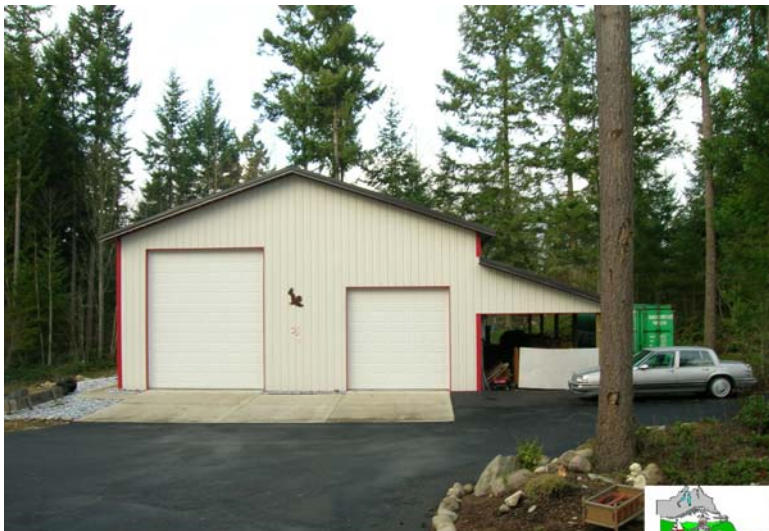
Average Quality
Pole Building

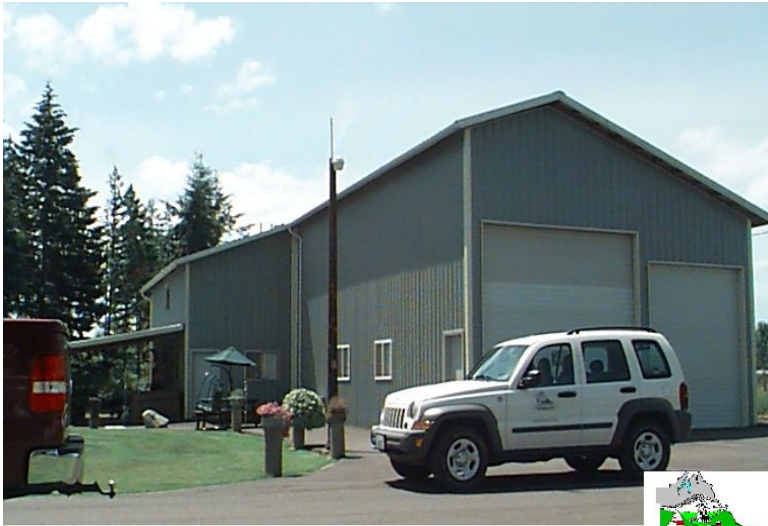
Average+ Quality
Pole Building

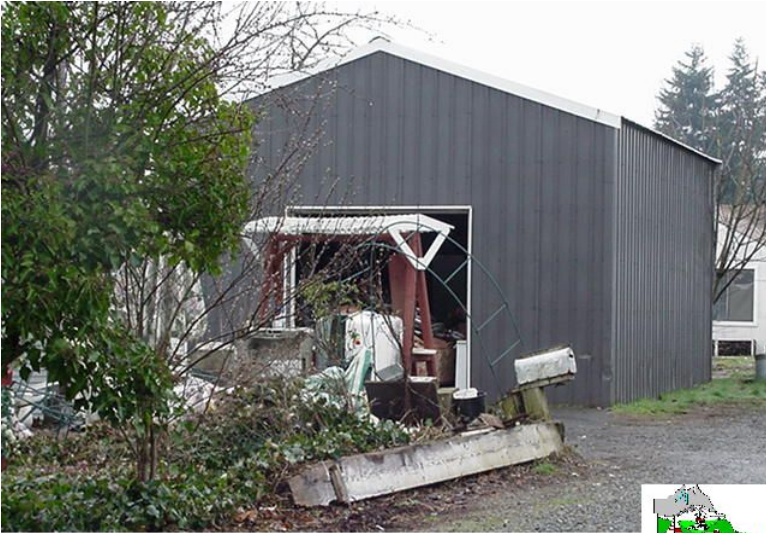
Utility buildings look similar to PBN-pole building but have frame construction.

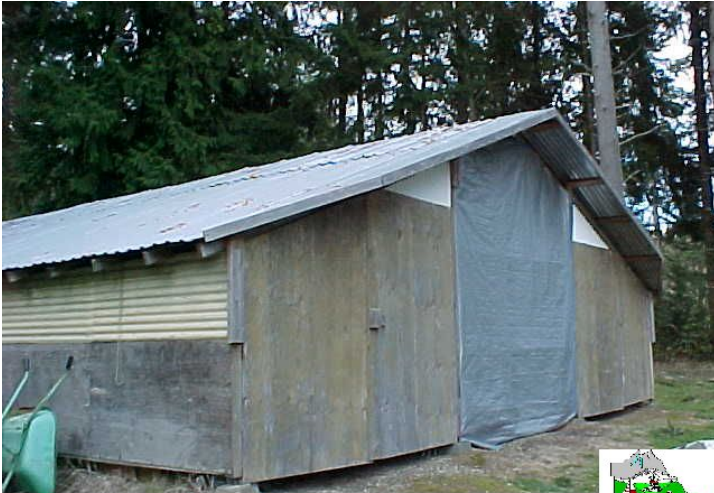
Low/Fair Quality
General Purpose

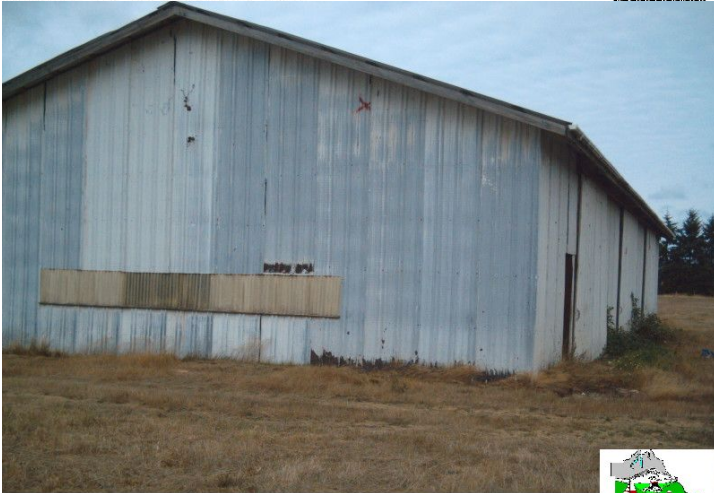
Fair Quality
General Purpose

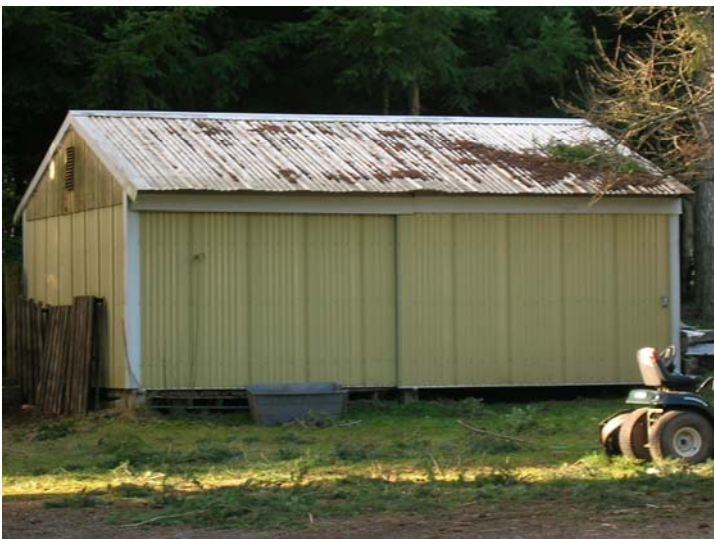
Average Quality
General Purpose Building

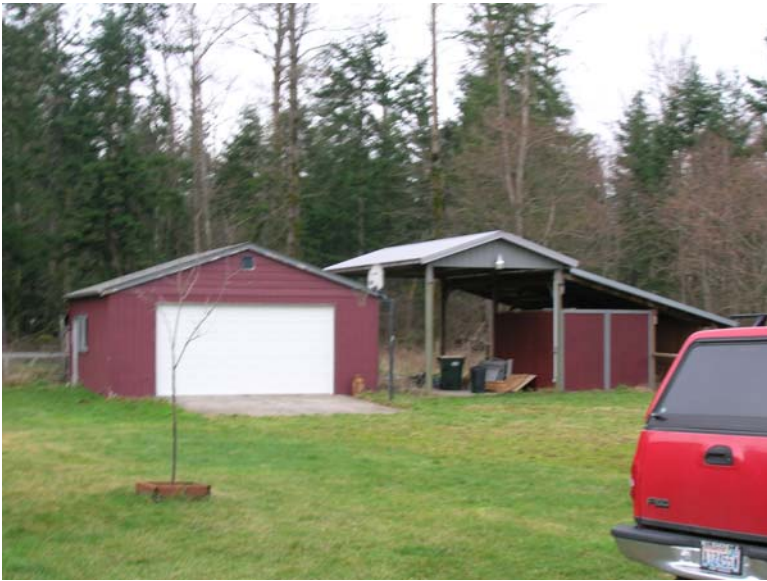
A cover is free standing, typically without sides. Rates change for each quality change.

Low Quality Cover

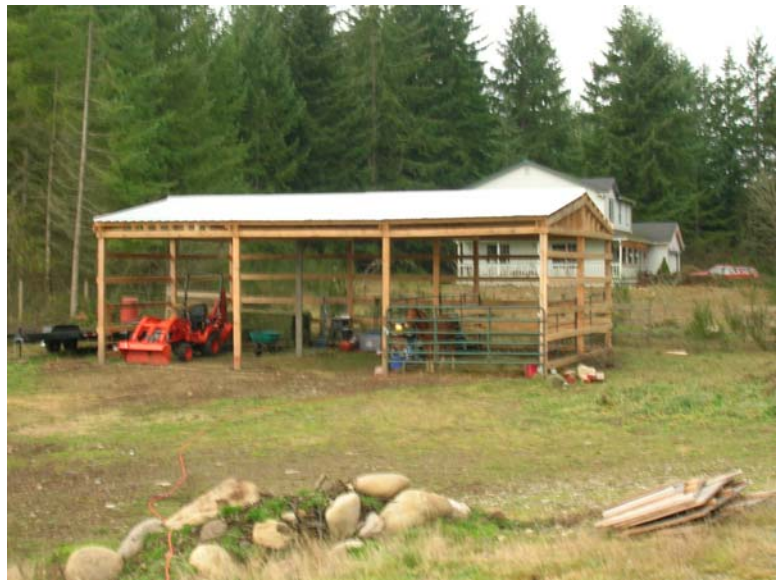
Fair Quality Cover

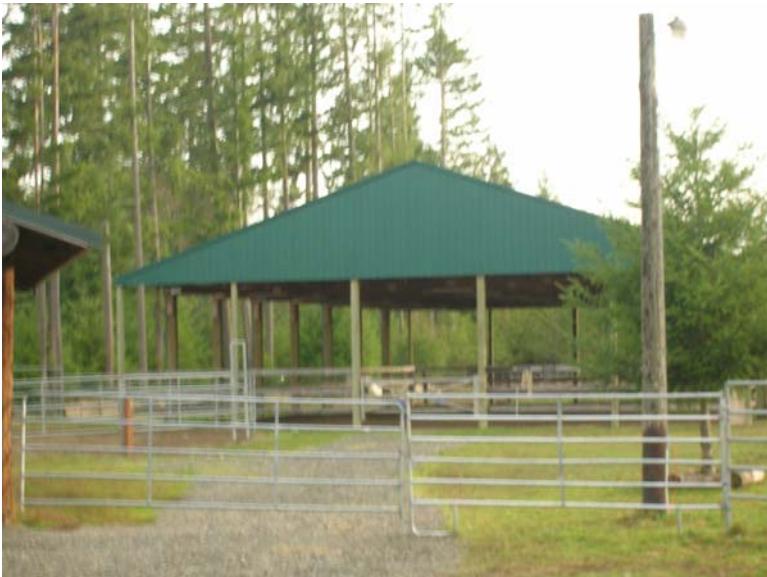
Good Quality Cover

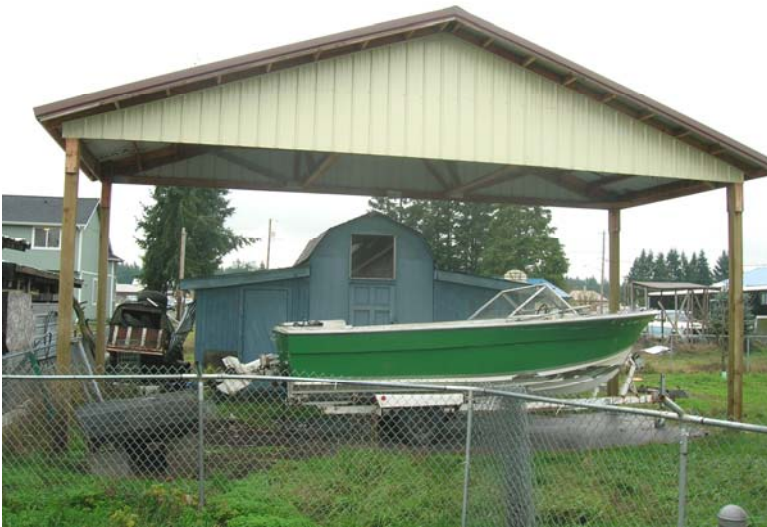
Designed and suitable for vehicle protection, a carport is usually a freestanding cover with a concrete pad or occasionally an asphalt pad below. A carport may occasionally be attached to another detached building, such as a detached garage. Its original purpose should appear to have been as a carport; otherwise, use CVR-cover or LNT-lean to. Quality is based on the complexity of the primary supporting structure and cover; however, any siding can be a sign of increased quality. Car Rates change for each quality change.

Fair Quality Carport

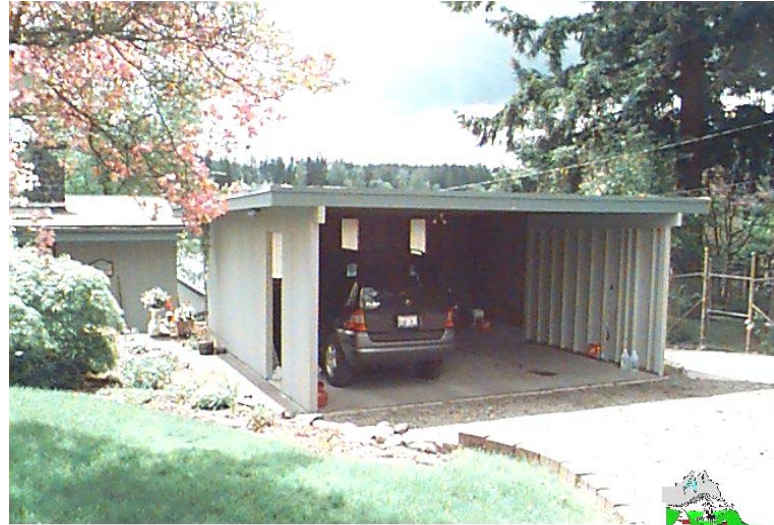
Fair Quality Carport

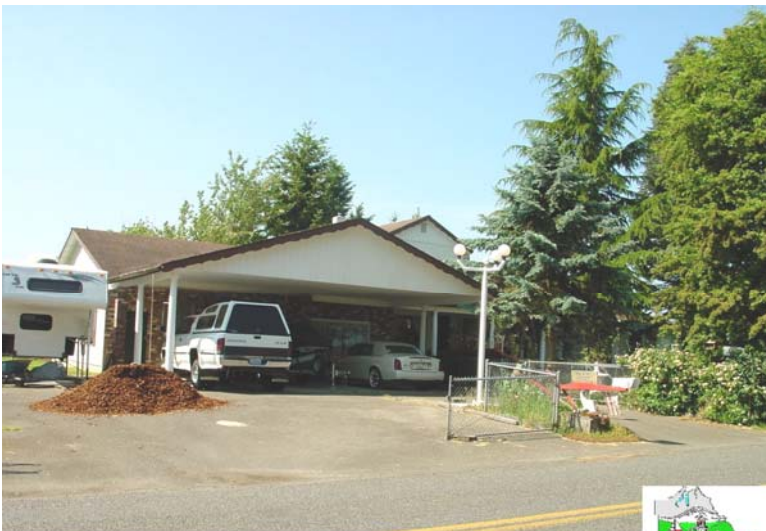
Average Quality Carport

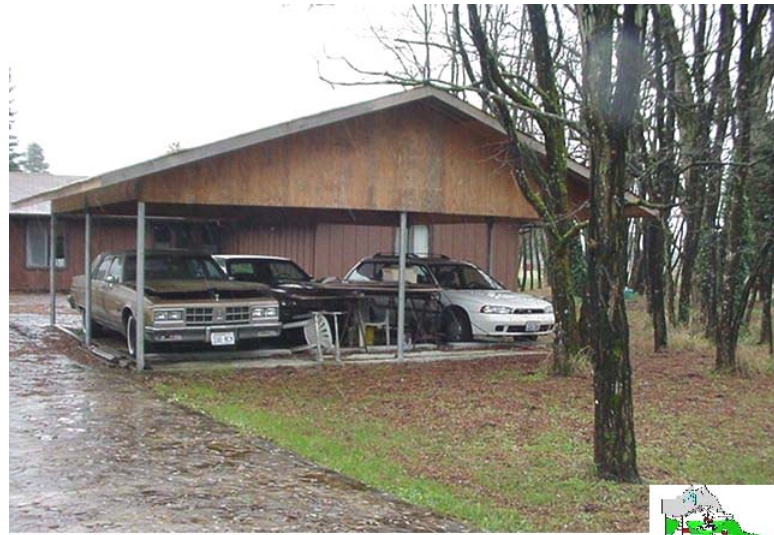
Average Quality Carport

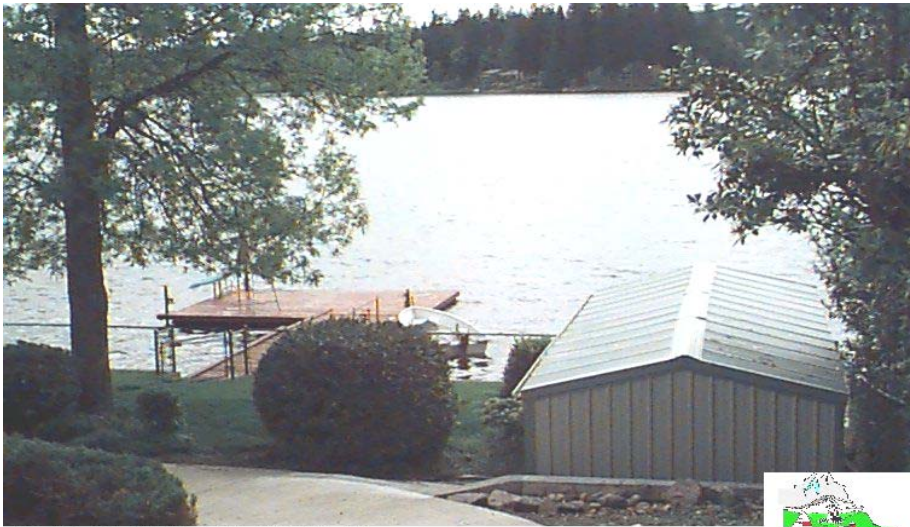
BTH—Boat-House - more of a cover, primarily commercial.
BTS—Boat-Shelter – enclosed structure; may have floor.
