ASSESSMENT DATA DEFINITIONS

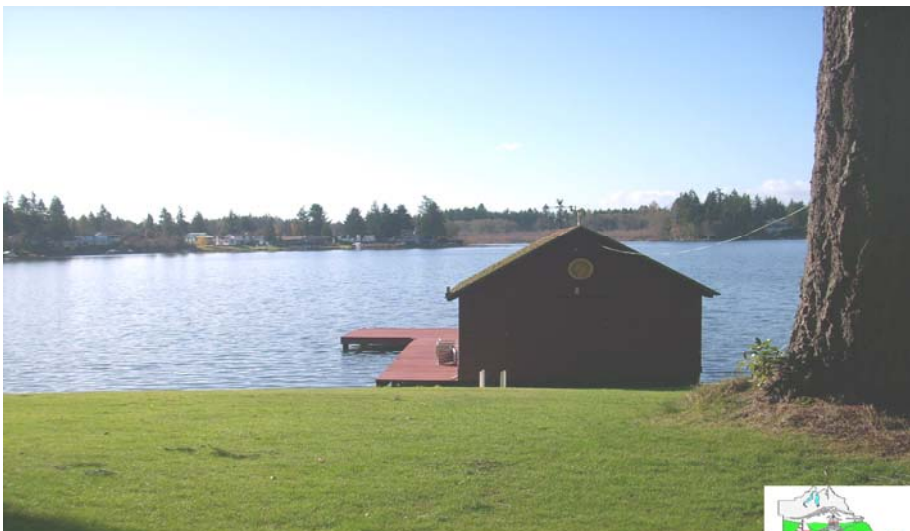
Fair Quality Boat Shelter

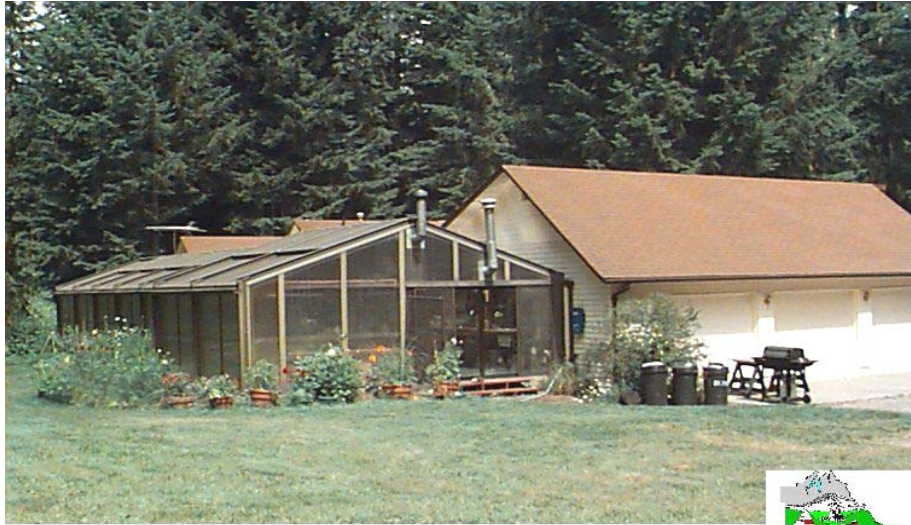
Greenhouses are structures enclosed with glass or commercial grade plastic for the purpose of the protection and propagation of plants.

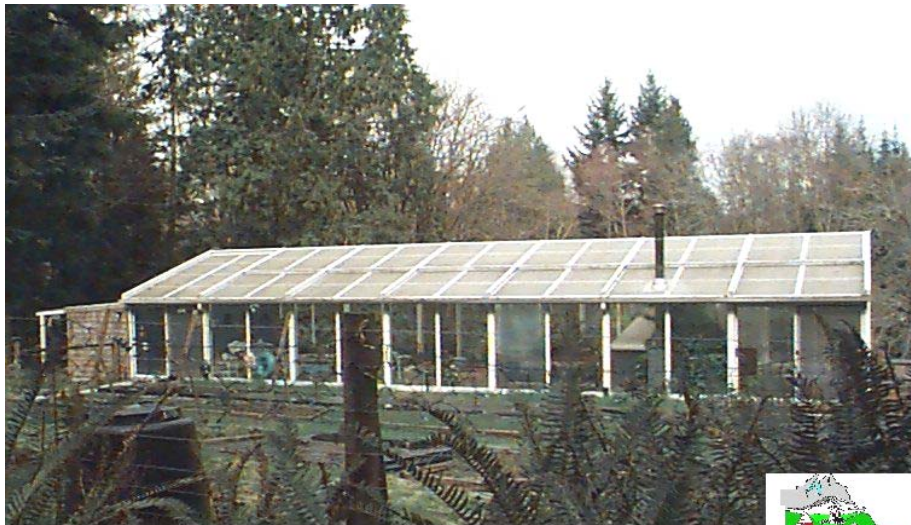
Fair Quality
Greenhouse

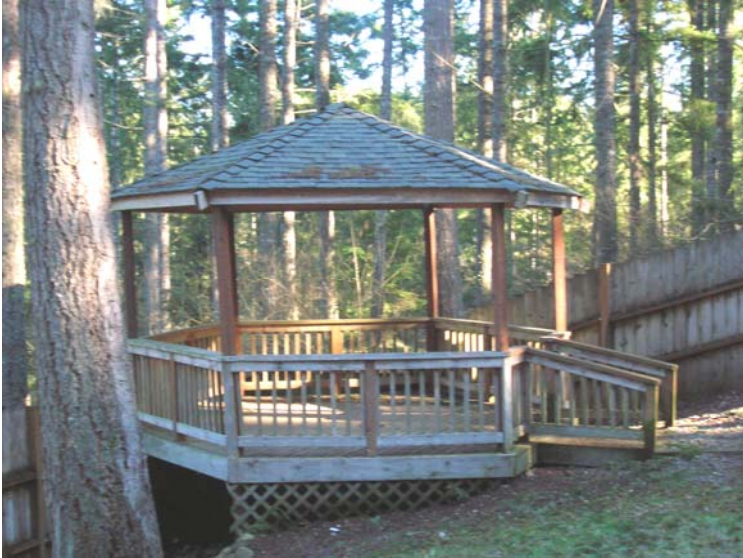
is a freestanding roofed structure typically open on all sides.

Fair Quality Gazebo

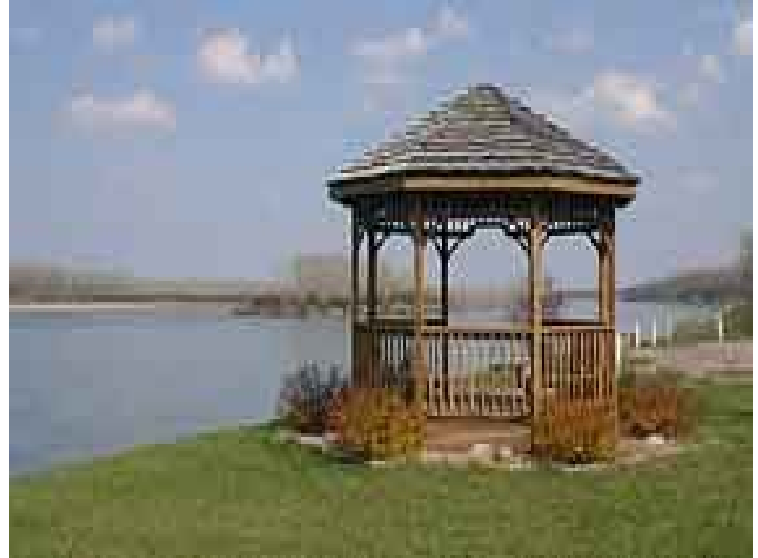
Average Quality Gazebo

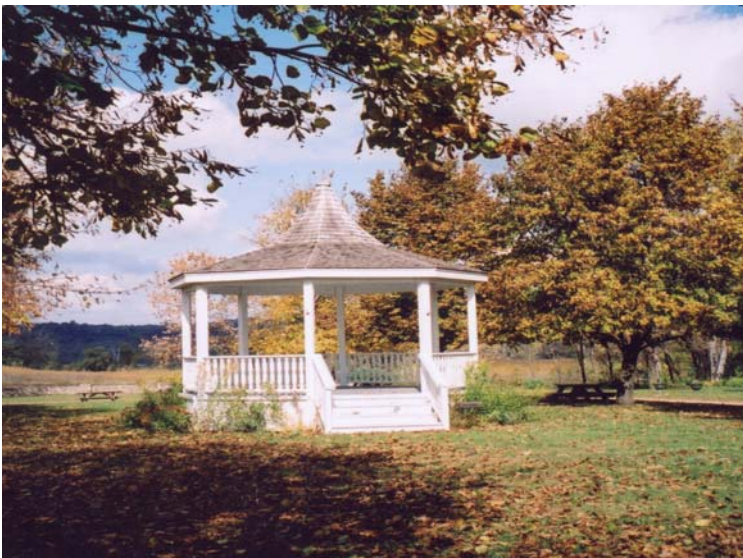
Good Quality Gazebo

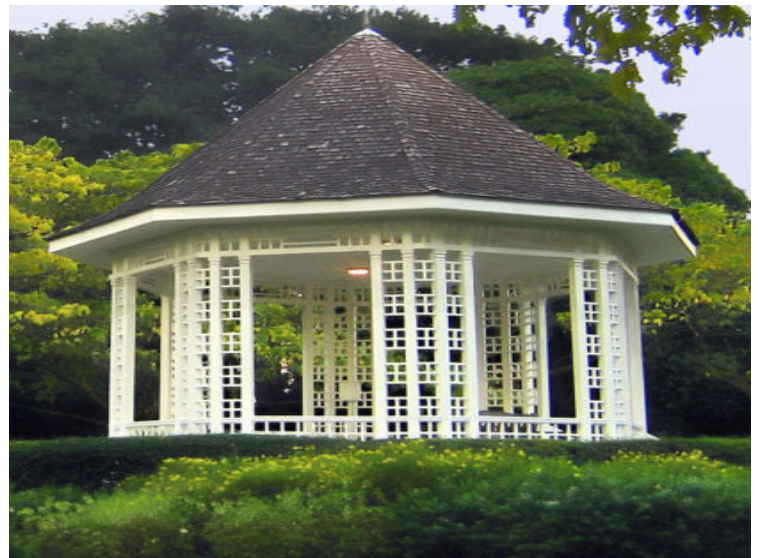
Very Good Quality Gazebo

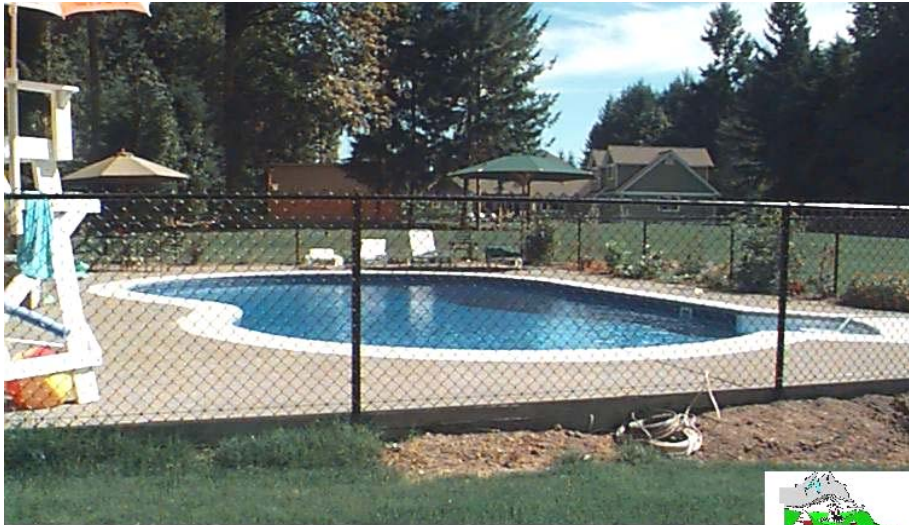
Both should have a 50% functional adjustment.

Good Quality
Gunit Pool

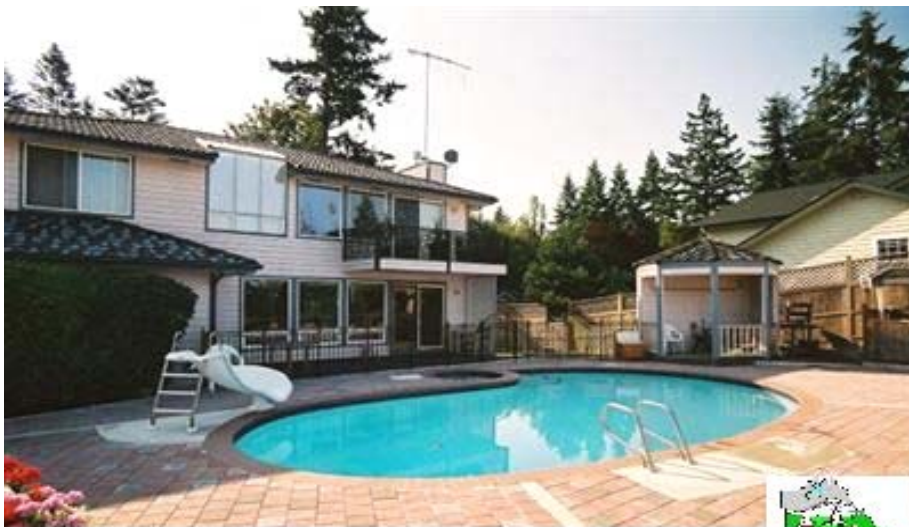
Good Quality
Gunit Pool

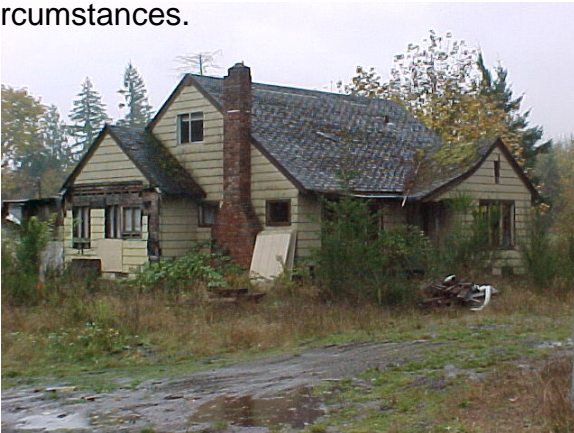
VERY POOR

House has been uninhabited for couple of years. Some windows and siding missing. Interior floors sagging; floor coverings in ruins. Musty wet smell on inside; peeling wallpaper, water stained ceilings, doors and cabinets either stuck shut or won't close. No appliances - would be scared to plug anything in. Comp roofing is sliding or missing in places, most likely rotted roof structure due to years of neglect. Salvage value only.

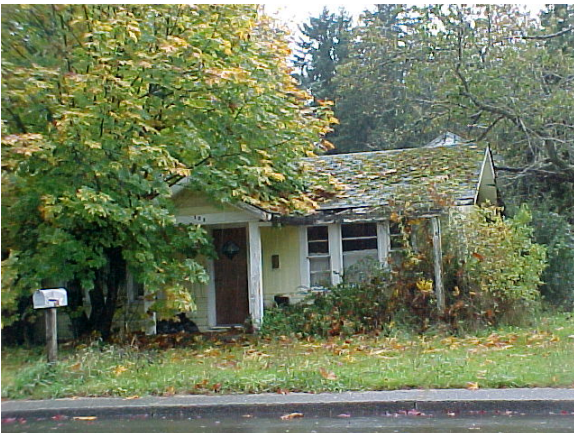
VERY POOR

House built 1931 and remodel done around 1964-65. Appears no maintenance done since. Roof deck is rotted, fascia boards rotting and falling down. Musty and moist inside. Barely livable at this time, but it is still being lived in.

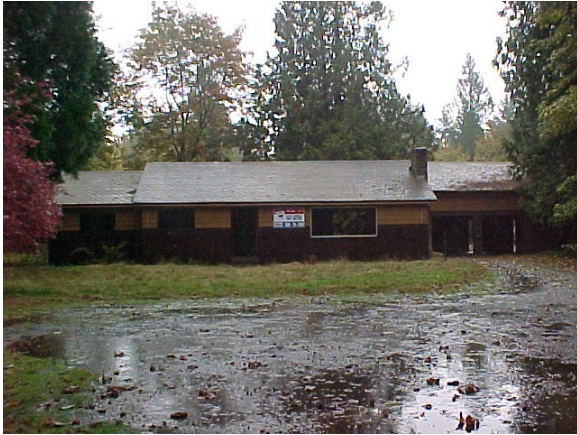
VERY POOR

House has been vacant for some time. Interior has all cabinets, wiring and plumbing fixtures, flooring, and windows removed. Has been heavily vandalized; stone fireplace broken to pieces; walls completely knocked out. Would take a major miracle to put this house into use again.

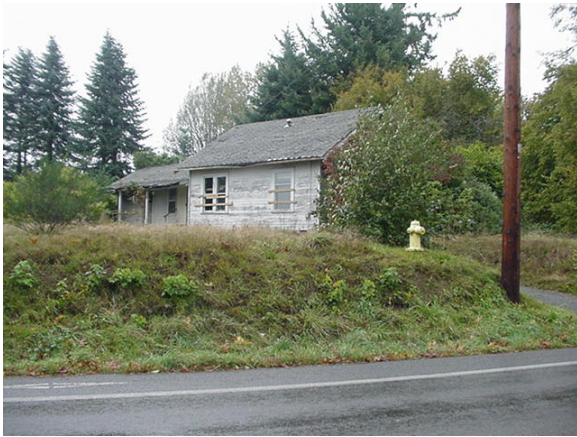
VERY POOR

The property is beyond repair. You may consider extra depreciation on home like this one.

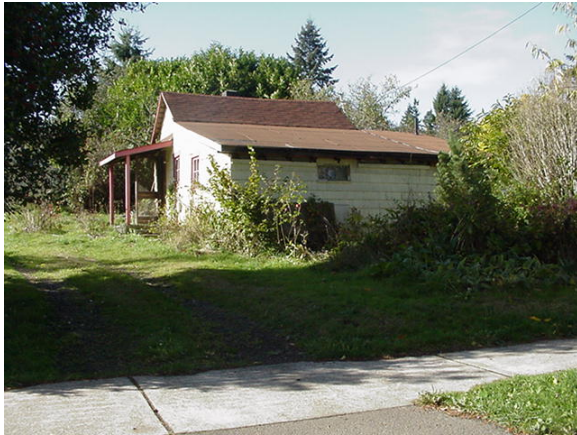
POOR

Major renovation needed to bring this property up to better standards.

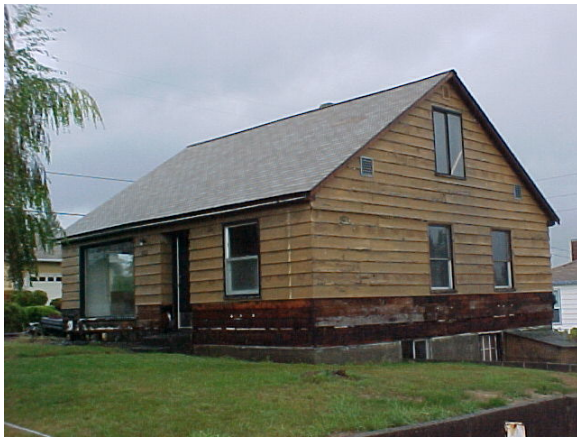
POOR

This house is currently undergoing some structural repairs to the sills, floor joists, girders, repairing bug and water damage to siding and framing. Interior needs some work, all original 1930's or 40's, major functional obsolescence in floor design and room layout.

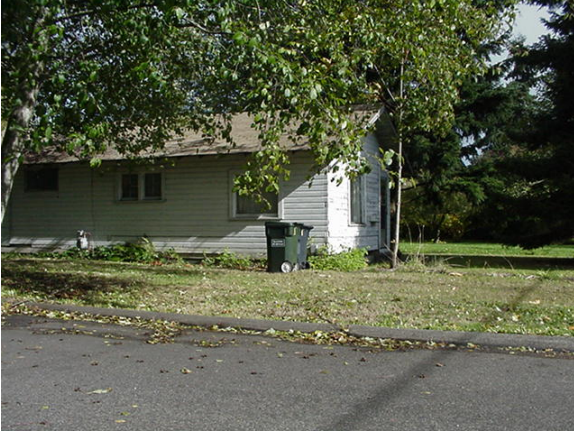
FAIR

There is a considerable amount of deferred maintenance. This home needs a new roof and the siding shows a lot of wear.

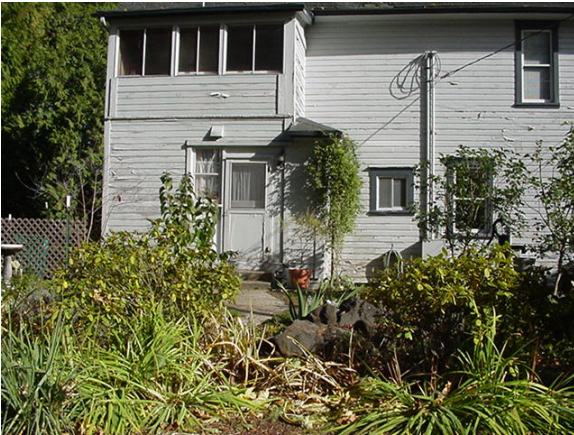
FAIR

There is a considerable amount of deferred maintenance. There appears to be some remodeling on the right side.

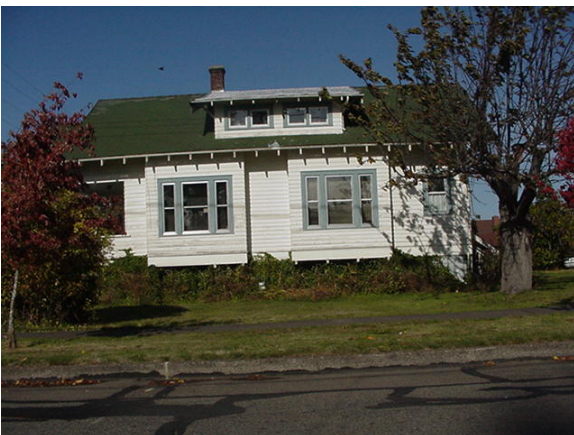
FAIR

There is a considerable amount of deferred maintenance. House needs paint, new roof, and foundation work. This property has received less than average maintenance for a house of its age.

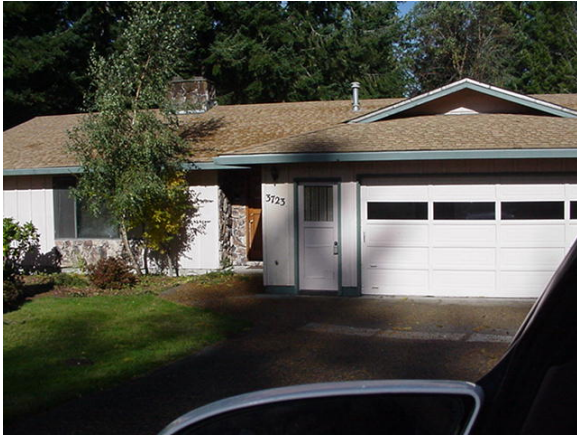
FAIR

There is a considerable amount of deferred maintenance. This property has received less than average maintenance and is not typical of the houses within its age range. The garage door needs to be replaced and the roof needs to be repaired.

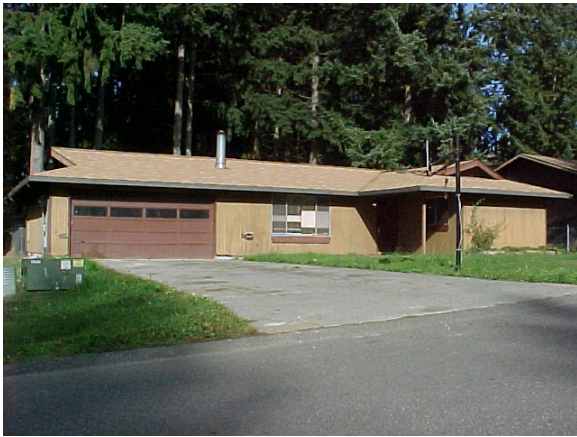
FAIR

House built in 1980 with less than average maintenance over the years. Many short-lived items need replacing like, floor coverings, stove-pipe interior and exterior paint, kitchen and bath countertops. Overall house shows heavy wear and some neglect.

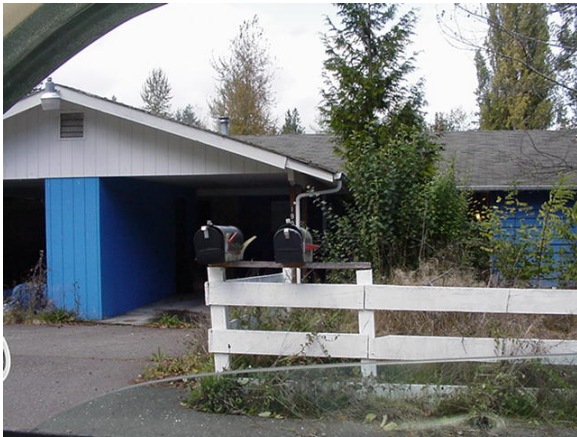
FAIR

There is a considerable amount of deferred maintenance. Many short-lived items are in need of repair or replacement. The roof shows a great deal of wear; the gutters are in rough shape and the exterior needs paint.

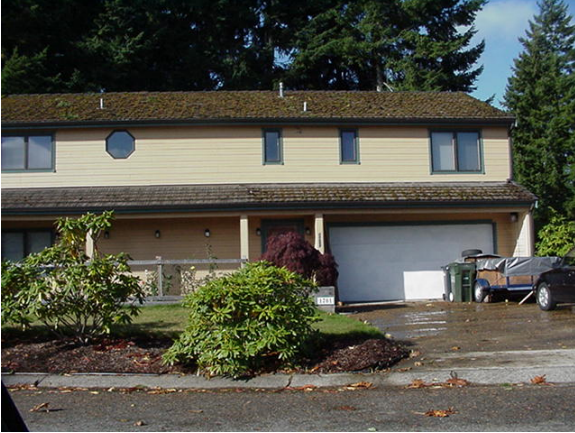
AVERAGE

This is evidence of deferred maintenance and normal deterioration. Some minor repairs are needed but most components have received normal maintenance.

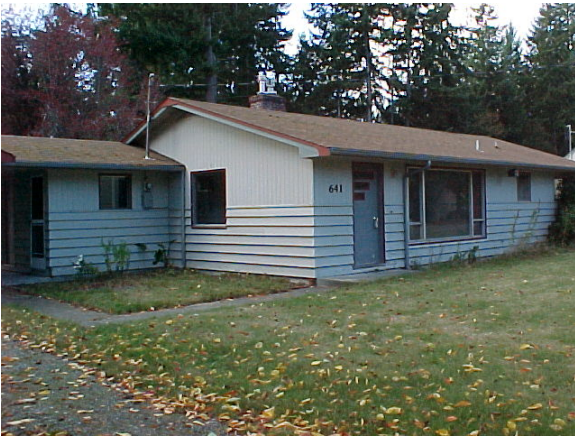
AVERAGE

House built in 1958 and has had normal maintenance done over the years but no major renovations or remodeling done. Some functional obsolescence for interior layout, long skinny living room enclosed long skinny kitchen most obvious.

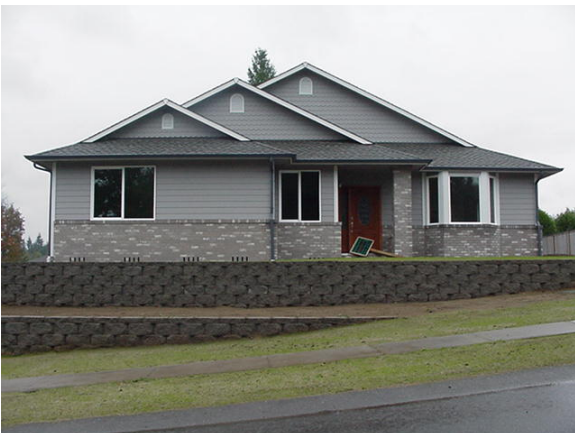
AVERAGE

This is a new house, and is in average condition for its age.

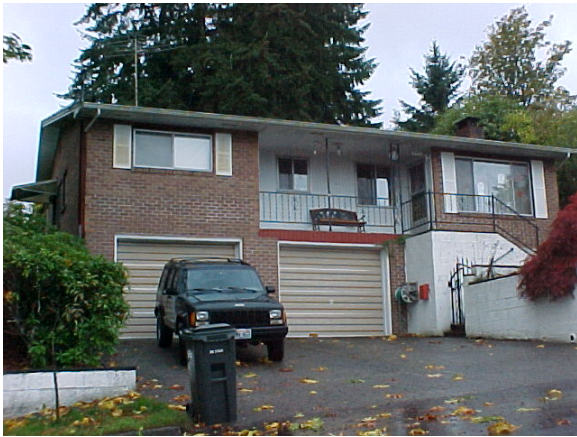
AVERAGE

House built in 1967, all original components are well maintained with many years of life left in them. Interior has had some upgrades and replacement of short-lived items. Other items not replaced but still functional.

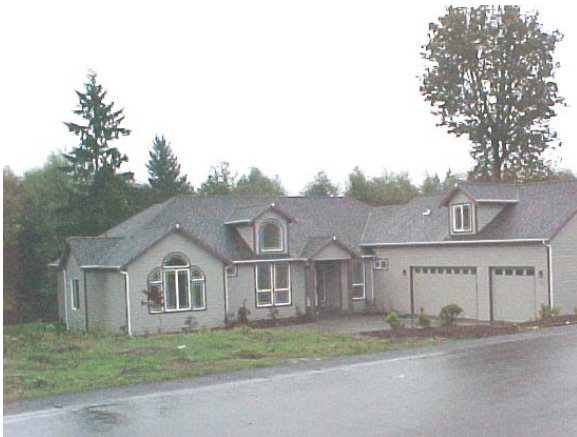
AVERAGE

House built in the late 1990's and has not had to have any components replaced or repaired yet. Is currently on the market so most likely it has just been steamed cleaned to make it sparkle.

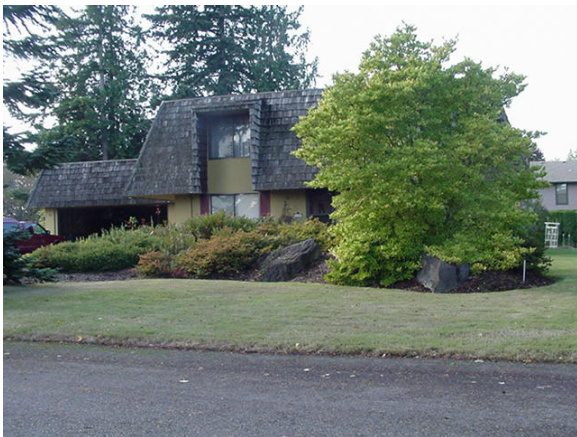
AVERAGE

There is some evidence of deferred maintenance and normal deterioration on the Mansard roof. Most components have received normal maintenance. The condition is typical for its age.

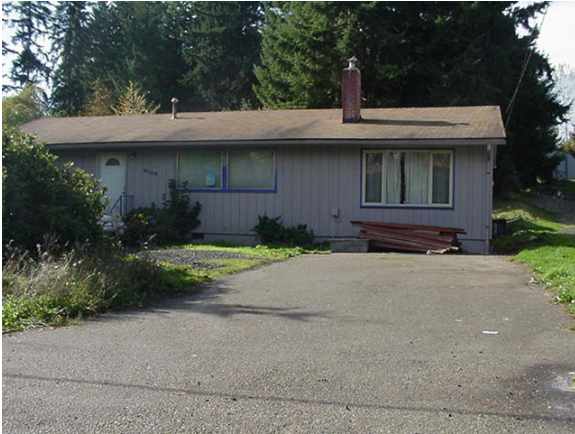
AVERAGE

There is some evidence of deferred maintenance and normal deterioration. Moss on roof. This home has a converted garage.

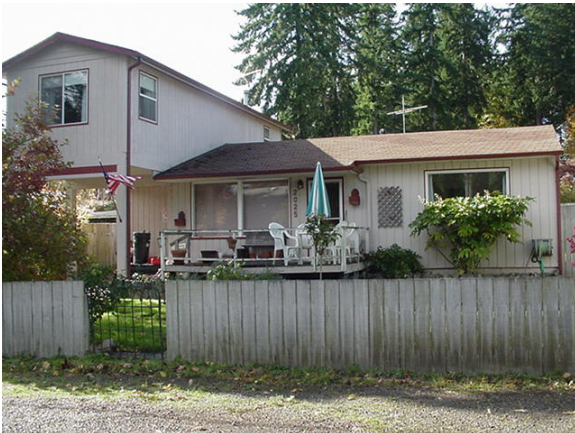
AVERAGE

There is evidence of deferred maintenance and normal deterioration. Note moss on roof and the railing on deck. Also, there is a new addition on the left side of the home

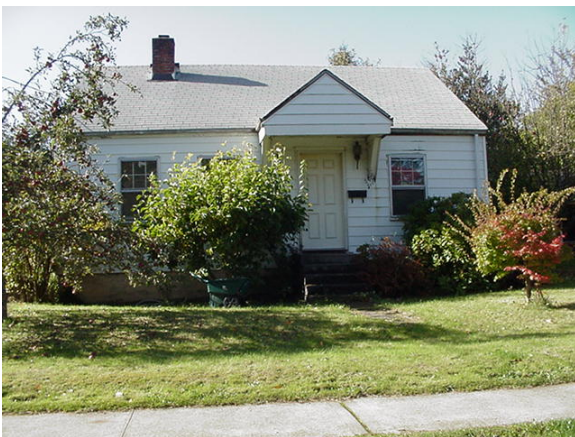
AVERAGE

There is some evidence of deferred maintenance and normal deterioration. Windows need to be replaced; otherwise, the house is in good condition.

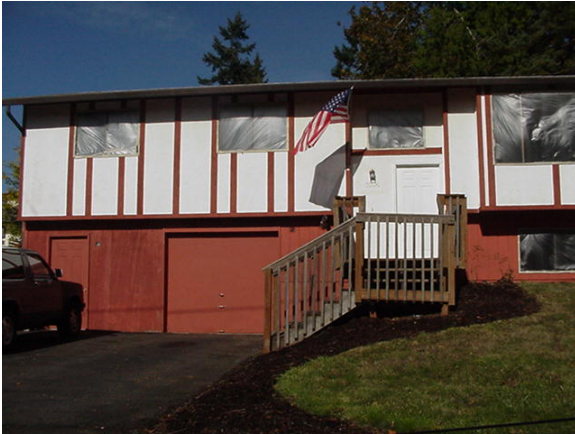
AVERAGE

There is no obvious deferred maintenance present, but neither are the improvements in new condition. Plastic placed on windows reflecting they have not been replaced.

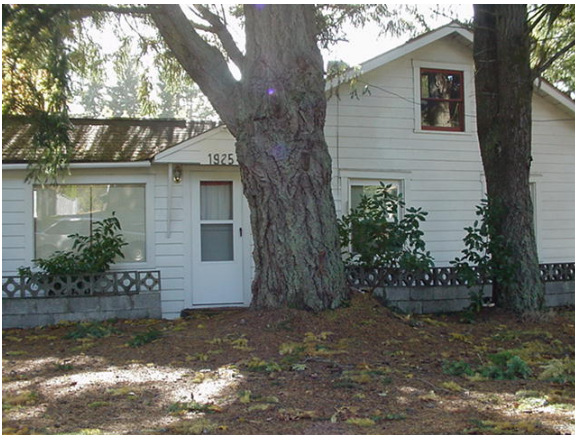
AVERAGE

There is some evidence of deferred maintenance and normal deterioration. Some minor repairs are needed but most components have received normal maintenance.

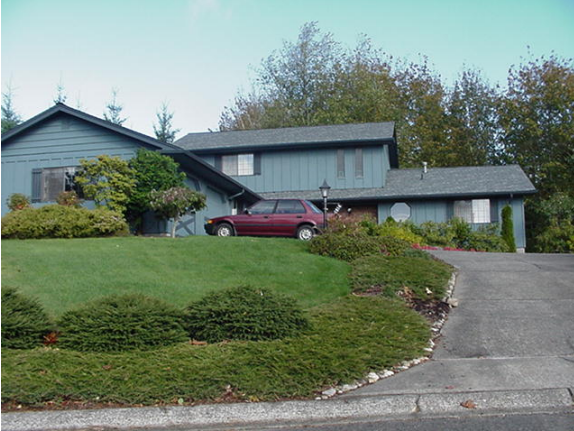
GOOD

All items have been well maintained. Most items are like new with very little signs of wear.

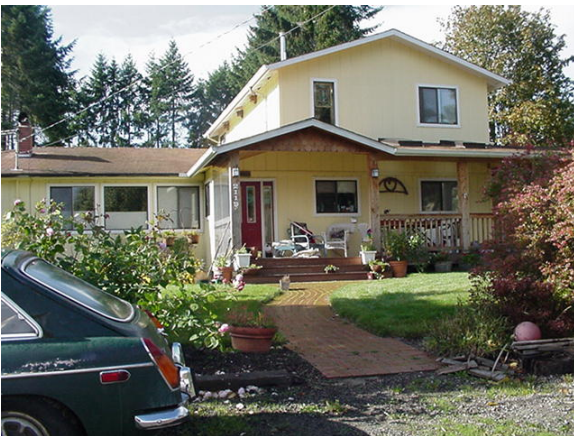
GOOD

All items have been well maintained. Most items are like new and shows no sign of there actual age. Very little deterioration is evident in any building component.

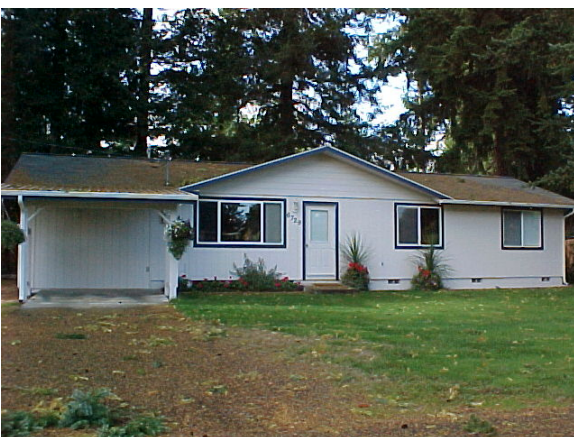
GOOD

House built 1976; has upgraded vinyl-windows, new roof cover, interior vinyl-flooring and carpet, and new interior and exterior paint. All other components appear to have normal maintenance.

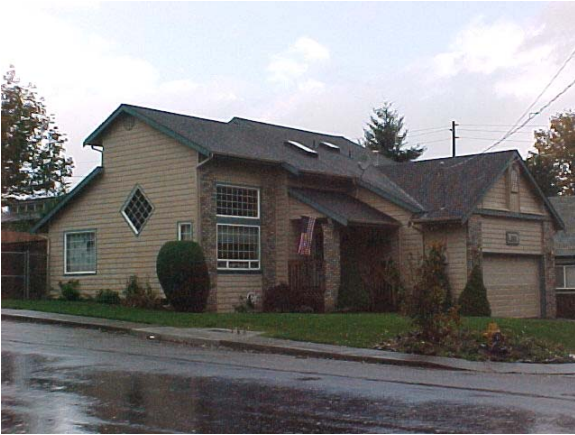
Good

Built in 1992, above-average maintenance, maintained schedule to keep all components looking in new condition. House appears much newer than actual age

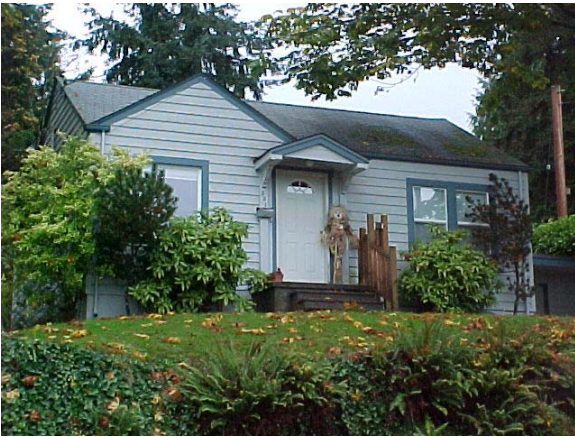
Good

House built 1930, remodeled approximately 1995, prior to being sold. Upgraded all short-lived components to include new vinyl windows, metal exterior doors, new kitchen and bath fixtures, cabinets flooring and so on. No wear and tear or physical deterioration noted.

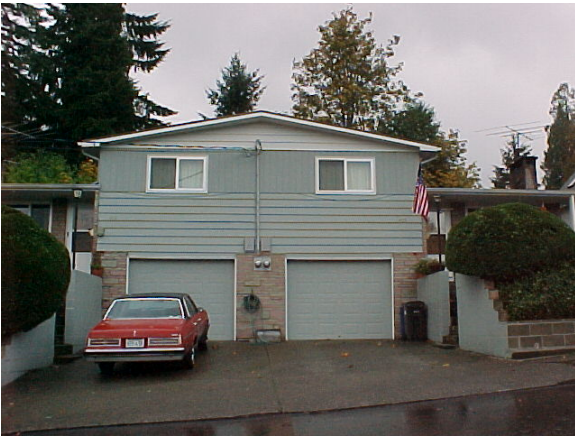
Good

Duplex built in 1958 has had exterior doors-including garage-and Vinyl-windows installed. Newer roof and siding replaced. Interior flooring, cabinets and trim work has been upgraded. Other components show little wear.

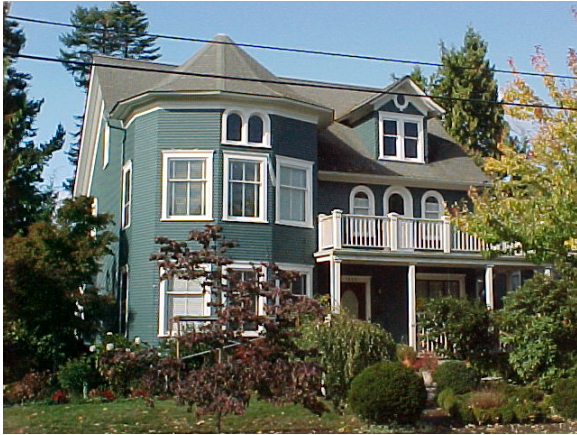
GOOD

Historic home in the South Capital area - built 1906. All original components have been well maintained. Roofing is new material but most other major components are original in order to keep historic designation. No obvious signs of any maintenance needed Functional obsolescence due to interior layout and design, vintage kitchen and baths.

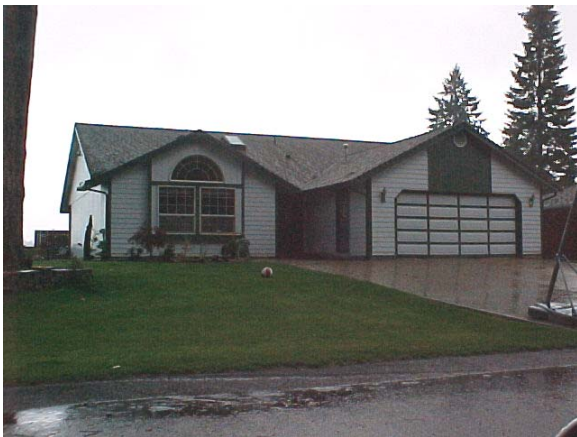
GOOD

House built in the early to late 1980's, has had normal maintenance, items repaired or replaced as needed. Shows very little wear or deterioration to all components.

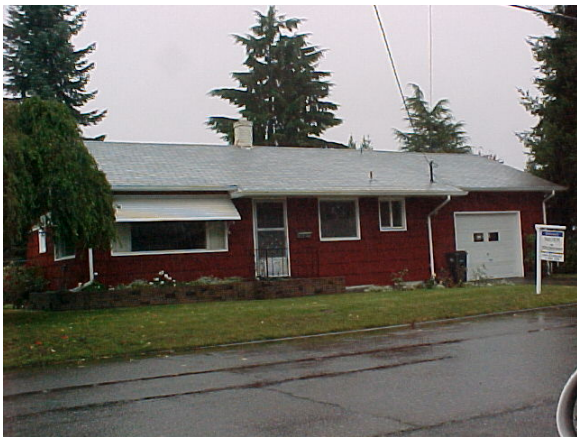
GOOD

House built in the late 40's- early 50's. Has new comp roof, vinyl windows, floor coverings, and overall spit shine to get ready to put on the market. Appears to have had above average maintenance over the course of life that would reduce the normal wear and tear a house this age usually shows.

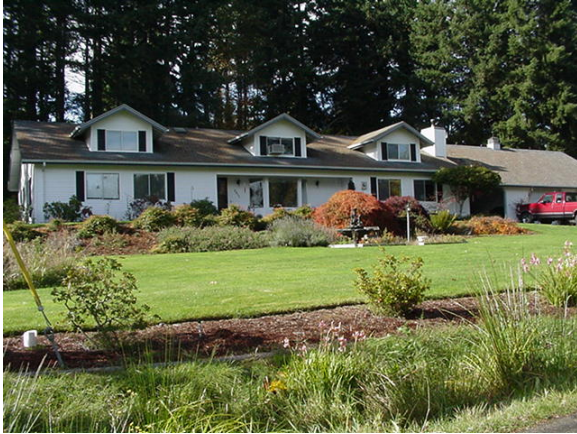
VERY GOOD

All items have been well maintained. Most items are like new and show no sign of their actual age. This home has been extensively remodeled and a major addition has been added.

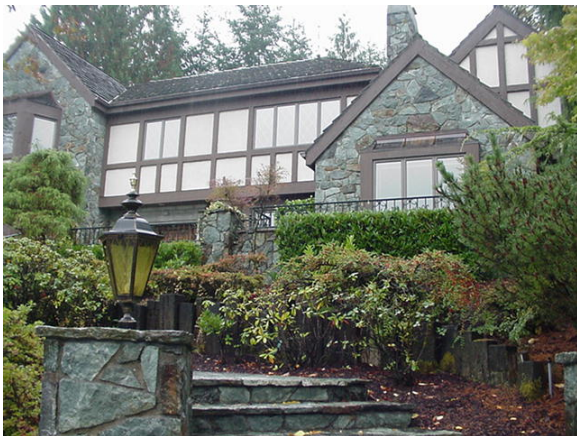
VERY GOOD

House built between 1981-1984; all items have been well maintained. There is no sign of actual age.

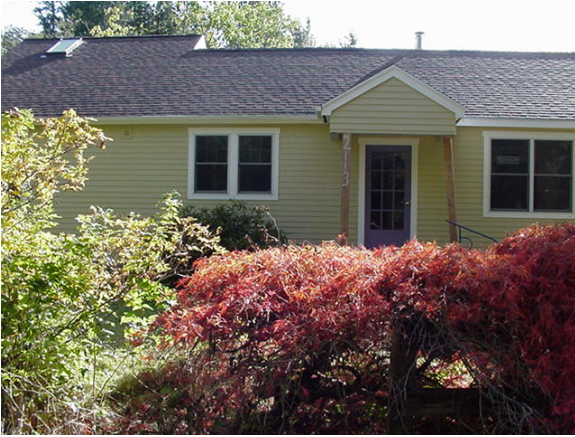
VERY GOOD

All items are new or are in like-new condition. This older home has undergone some remodeling with new additions in the last two years.

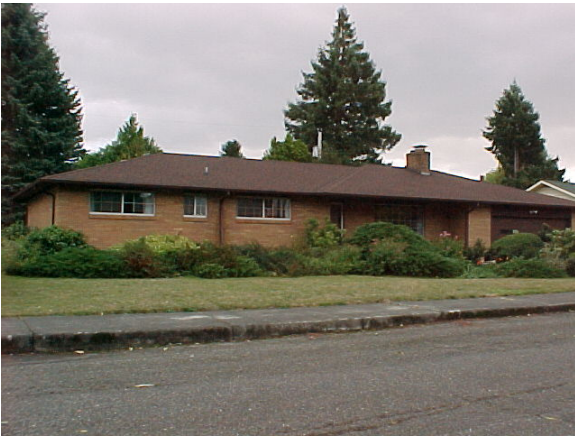
VERY GOOD

House built in 1961; has had above normal maintenance. Interior has had many face lifts over the years. Kitchen fully remodeled, floor coverings replaced, new trim, cabinets, interior doors, plumbing and electrical fixtures, vinyl windows and roofing. No signs of any wear and tear.

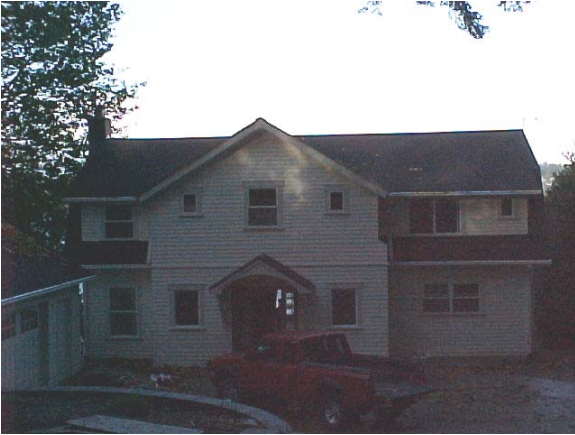
EXCELLENT

House totally gutted down to frame, everything new except foundation framing and exterior siding. Nice custom work being done on interior; will be wonderful home when finished.

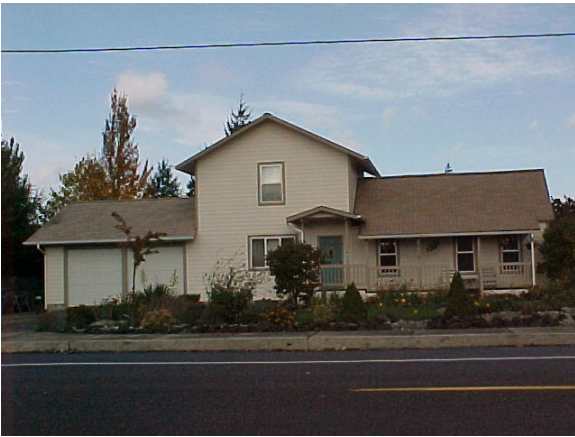
EXCELLENT

Original house built in 1920, 697 square feet, two story addition with double garage was added in 1994. Old portion of house totally renovated. New plumbing, electrical, roofing, windows, doors, flooring, drywall, plumbing and electrical fixture. All short-lived and some long-lived items replaced.

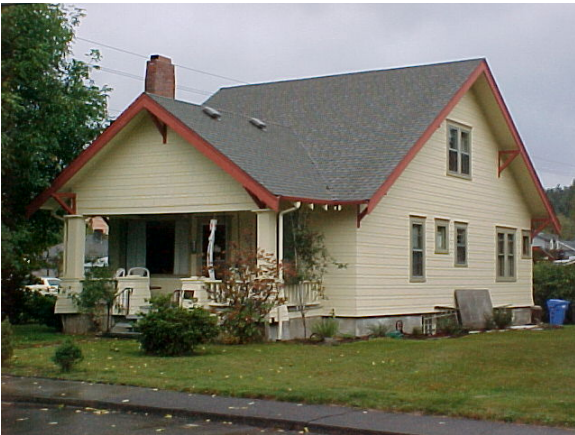
EXCELLENT

House built 1930 has been fully remodeled/refurbished. Interior fully remodeled with upgraded electrical and plumbing. New gas furnace replaces old oil furnace; new exterior siding, roofing, vinyl-windows and doors. Interior rooms opened up to allow natural lighting; good room flow.
